A System Theoretic Analysis of the “7.23” Yong-Tai-Wen Railway Accident

Dajiang Suo

Computer Science and Technology Dept.
Tsinghua University, 100084, Beijing, China
sdj08@mails.tsinghua.edu.cn

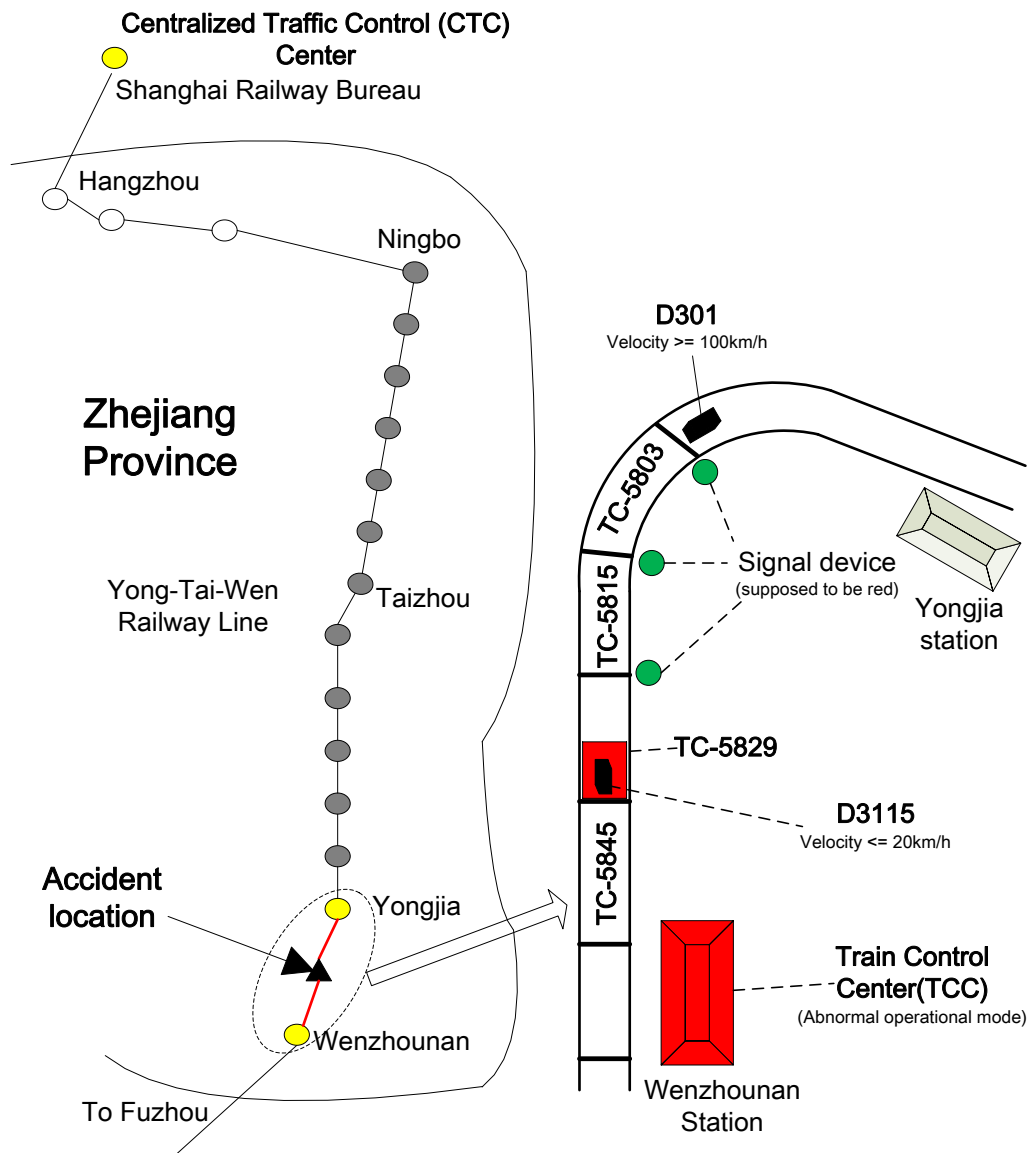
Figure 1. The location of the accident and its surrounding environment

Red light strip (shown in Figure 1) – In the displays of the TCC, it often represents the occupancy of the Track Circuit by the train. But sometimes the abnormality in the Track Circuit may lead to red light strip. Therefore, the appearance of the “Red light strip” indicates that a particular track section is occupied by a train or its related track Circuit is failed.

Both D3115 and D301 were behind schedule and reached Yongjia railway station at 19:51 and 20:12, respectively. The Railway station changed its operational mode from automatic control to abnormal control (man-control) because of a failure in the track circuit. A “Red-Light strip”, which represents the occupancy of the railway section, appeared in the monitor of the CTC, but actually there was no train in that section. At 20:14, D3115 left Yongjia station and reached 5829AG at 20:21. Due to the failure of Track circuit, it stopped automatically for nearly eight minutes and failed to restart until 20:29. After that it kept running at the speed almost 20 kilometers per hour according to the railway regulation under abnormal conditions. At the same time, D301 also left from Yongjia station to Wenzhounan station at 20:24 and was supposed to decelerate when it received signals from the Track circuit or encountered the red light of the signal device. Unfortunately, failures in the TCC made erroneous signal sent to D301 and the signal light, indicating that there was no train in section 5829 and the signal lights in section 5815 and 5803 turned green. As a consequence, D301 did not stop or decelerate at Section 5815 and 5803 (As shown in Figure 1).

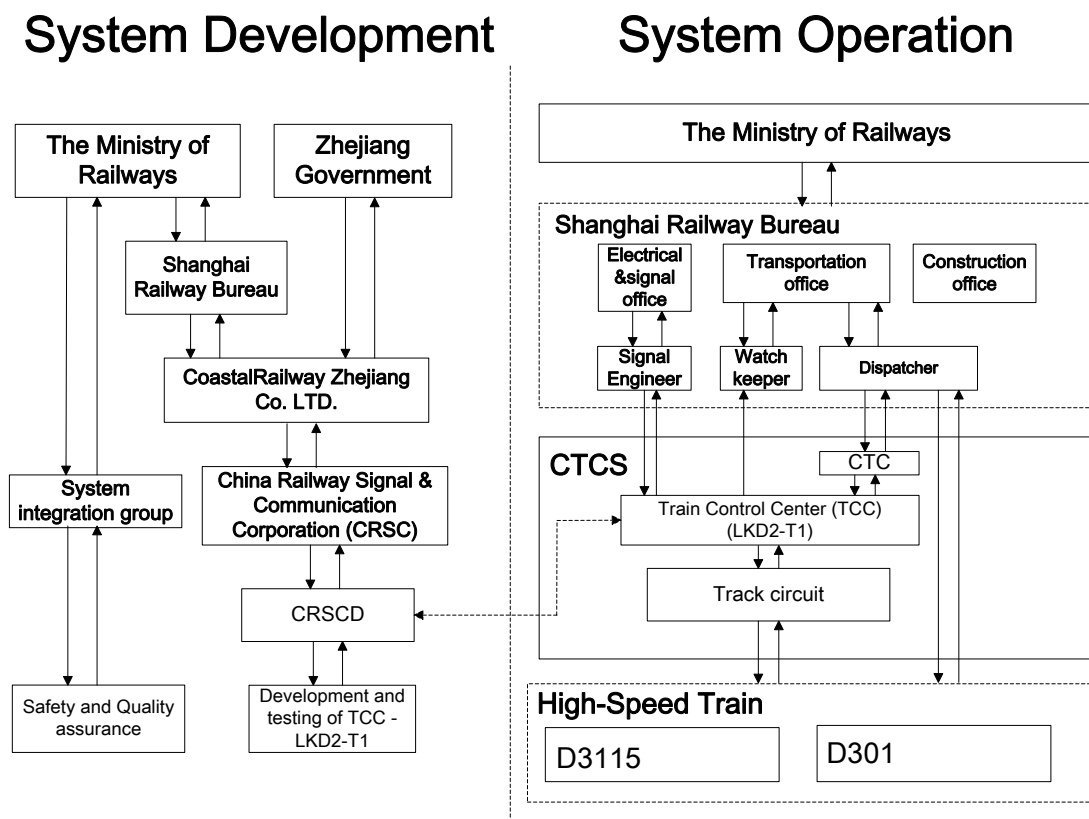
Figure 3. Safety control structure of the High-Speed train accident

The safety control structure includes both the construction of the high-speed railway line within Zhejiang Province and the operation of the Yong-Tai-Wen railway line, which is shown in Figure 3. It includes the High-Speed Train (D301 and D3115), the whole CTCS2 system, the Shanghai Railway Bureau and the Ministry of Railways on the right. The development structure (on the left) only incorporates those involved in the development of the signal&communication system because failures of signal devices are believed to be one of the main reasons for the accident. As mentioned before, there are two operational modes in this system (DACM and USCM). In the former, the CTC issues scheduling commands which transmit through TCC and the LEU and finally reach the ATP, which monitor the status information from the Track Circuit. If there is a Red light strip, the TCC will transmit to the USCM in which the train will be controlled by the coordination between the driver and the watch keepers in the station.

On the left of Figure 3 is the safety control structure of system development. The Coastal (Yong-Tai-Wen) Railway is its subsidiary company of Zhejiang Railway which is a state-owned liabilities limited company. It cooperates with the Ministry of Railways on behalf of the government of Zhejiang Province to holds and runs related national assets of jointly built railways. To make the discussion simple and easy to understand, Zhejiang Railway and the Coastal (Yong-Tai-Wen) Railway are referred to as Coastal Railway as a whole. It is responsible for the contract of investment and construction of the Yong-Tai-Wen coastal railway line in Zhejiang Province. The China Railway Signal&Communication Corporation (CRSC) is the contractor of the signal and communication system of the Yong-Tai-Wen railway line and responsible for the system integration of signal device. It also provides Track circuit to the CTCS system. Beijing National Railway Research&Design Institute of Signal&Communication Co., Ltd. (CRSCD), a subordinate enterprise of CRSC, designed and developed the TCC system – LKD2-T1.

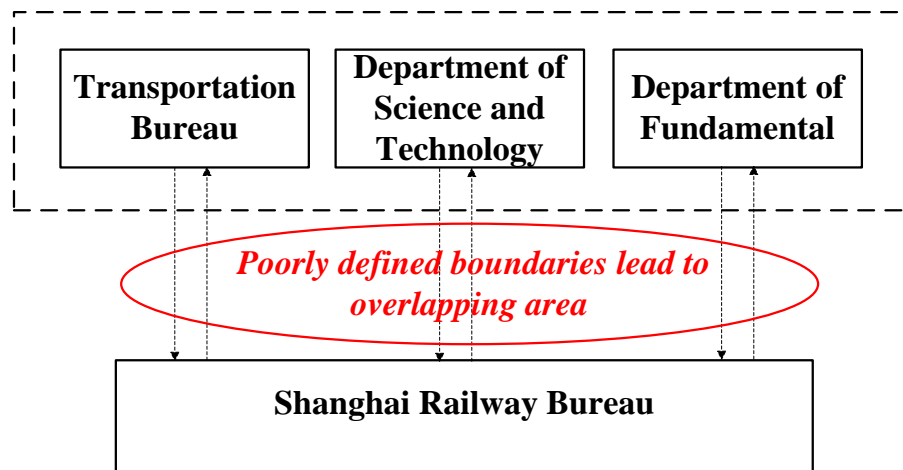
Figure 6. The Ministry of Railways

As in many other cases, the MOR did not have a specialized department which is responsible for safety issues. Both the newly established system integration group and the three departments have safety supervision as part of their responsibilities. Unfortunately, neither of them performed detailed risks and hazards analysis to ensure the safety of the signal system.

1. The inability of the Ministry of Railways to perform hazard analysis and safety assessment beforehand played an important role in the accident. In particular, although it established a department responsible for safety issues in high-speed railway projects, poor coordination among various sub-organizations made it ineffective in identifying and controlling the potential hazards. From a control perspective, overlaps existed among multiple controllers. In this case, none of the project integration group and other departments involved in establishing safety assessment procedures took the responsibility to strictly supervise system development, especially the products of signal and communication. Thus, a reasonable effort might be made in establishing an independent safety-related department (In fact there is one but failed to take the responsibility) so that overlap in responsibilities could be prevented. Moreover, safety regulations should be strictly enforced. Specifically, hazard analyses are necessary before and after the construction of the project and safety departments have the right to halt the development process of the project if there is witnessed evidence confirming the existence of potential hazards which might lead to accidents.

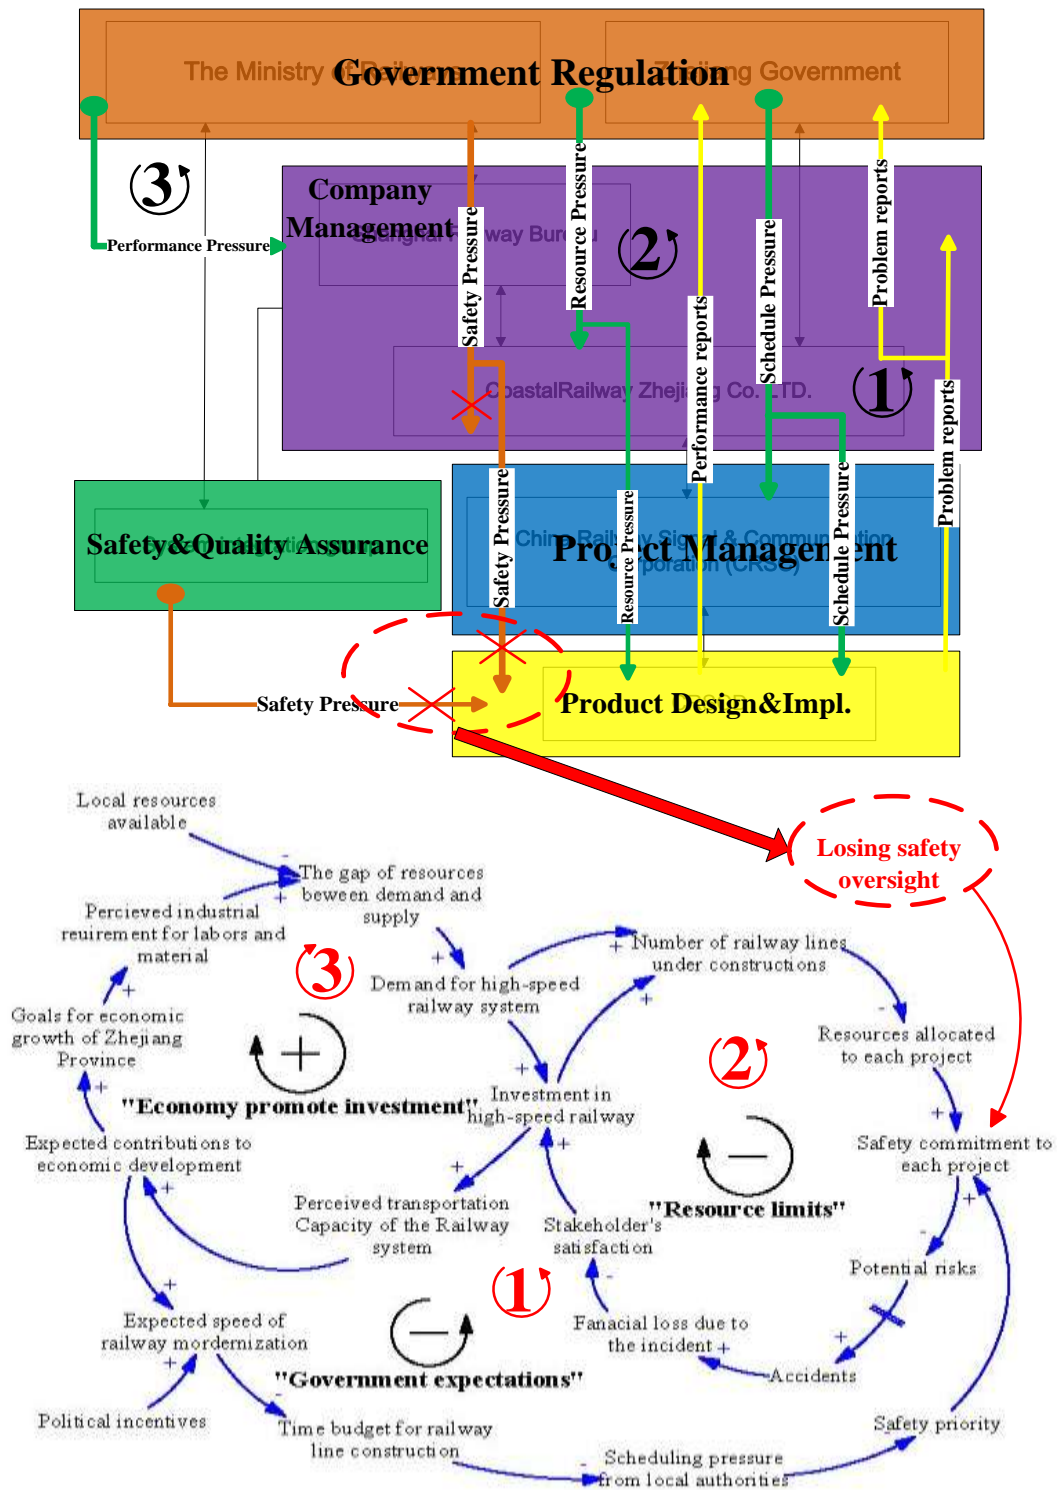
Figure 7. System dynamics of Zhejiang high-speed railway development

high-speed railway projects were cut by the minister of Railways and all the projects were stop temporarily for a complete safety inspection and this situation was reflected in the balancing loop “government expectations” (bottom of Figure 7).

The other two causal loops (no. 2 and no. 3) in Figure.7, including one reinforcing loop which promote investment to the railway in Zhejiang Province and one balancing loop which would change resource allocation on each project due to decrease in stakeholders’ satisfaction with the project, could also be build as no.1 causal loop. As noted above, we do not distinguish different generic dynamic components but only consider the influence of these channels in STAMP on system safety and have it reflected in the dynamic risk management model. One thing should be addressed is that the project as a whole tend to decrease safety priority and commitment to safety due to other pressures. To make things worse, the channels for reinforcing safety oversight and transmitting safety pressures are missing for lack of safety resources and complacencies (red ellipse in Figure 7). It is pointed out in the investigation report that leaders in the CRSC believed that there are no problems with the signal&communication products because of the oral reports they received from the sub-organization. Consequently, they design flaw in the TCC was not discovered during the testing process. If safety oversight had been reinforced externally, or the project contractor, in this case the CRSC, had received more safety pressures from the management company, the safety commitment could have been maintained.

The second causal loop “resource limits” depicts total resources available to each projects and its impact on the safety situation of each project. Like the one described in [9], as the numbers of projects grew, the gap between the required capital resources and the funds provided by the stakeholders led to compromises in quality of design and the execution of safety regulations. The increasing potential of risks caused by Poor supervisions and coordination becomes inevitable. As a result, the rise in the accident rate made stakeholders unsatisfied with the project and the investment become less. In fact, the situation described above is the same with what happened after the 7.23 accident.

2. The local government of Zhejiang province also contributes indirectly to leading the railway system into a hazardous state. Too many parallel projects caused by economical incentives result in a deficiency of resources in terms of funding, manpower and facilities, so that safety efforts tend to be ignored during the development of railway lines. Therefore, a scientific balance should be made between the safety and pace of development.
