PRELIMINARY CAST ANALYSIS OF THE LAMIA CP-2933 ACCIDENT

Carlos Lahoz & Idoaldo Lima
Instituto Tecnológico de Aeronáutica (ITA), Brazil

2017 STAMP Workshop
Thursday March 30

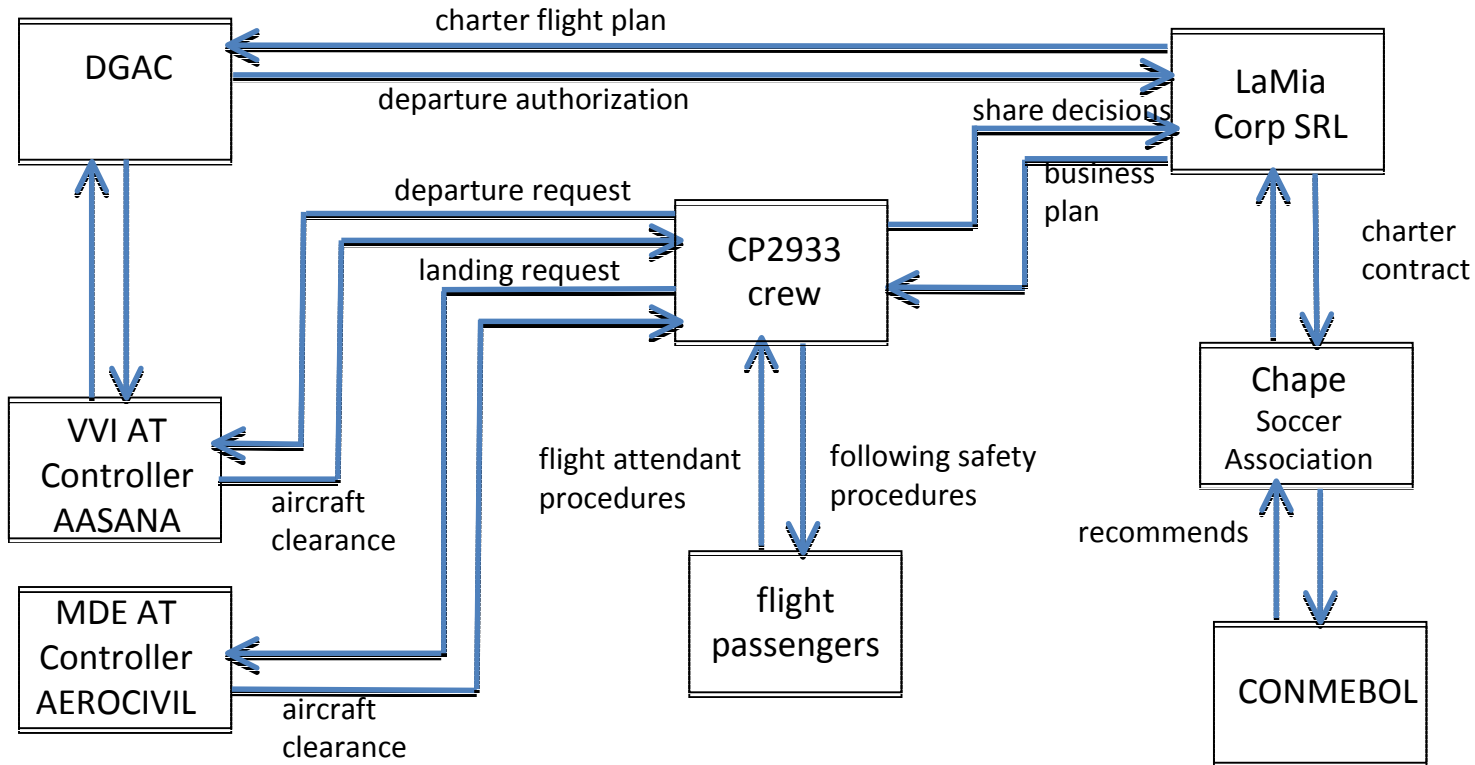
CAST: Safety Control Structure

LaMia Corp SRL : Línea Aérea Mérida Internacional de Aviación

DGAC (General Directorate of Civil Aviation, Bolivia) : is responsible for the technical supervision of aircraft in Bolivia and to approve the flight plan

Chape: Chapecoense Soccer Association, Brazil, including players, coaching and other club staff , guests and journalists

CONMEBOL: South American Soccer Confederation, South America.
