2017 (6th) MIT STAMP Workshop
MIT, Cambridge, USA
30th March 2017.

Applying Causal Analysis based on STAMP (CAST) Accident Analysis

Case Study: Runway Incursion
Tenerife North (Los Rodeos) Airport: March 1977

Mr Simon Whiteley BEng (Hons) MSc MRAeS
Whiteley Aerospace Safety Engineering & Management Limited

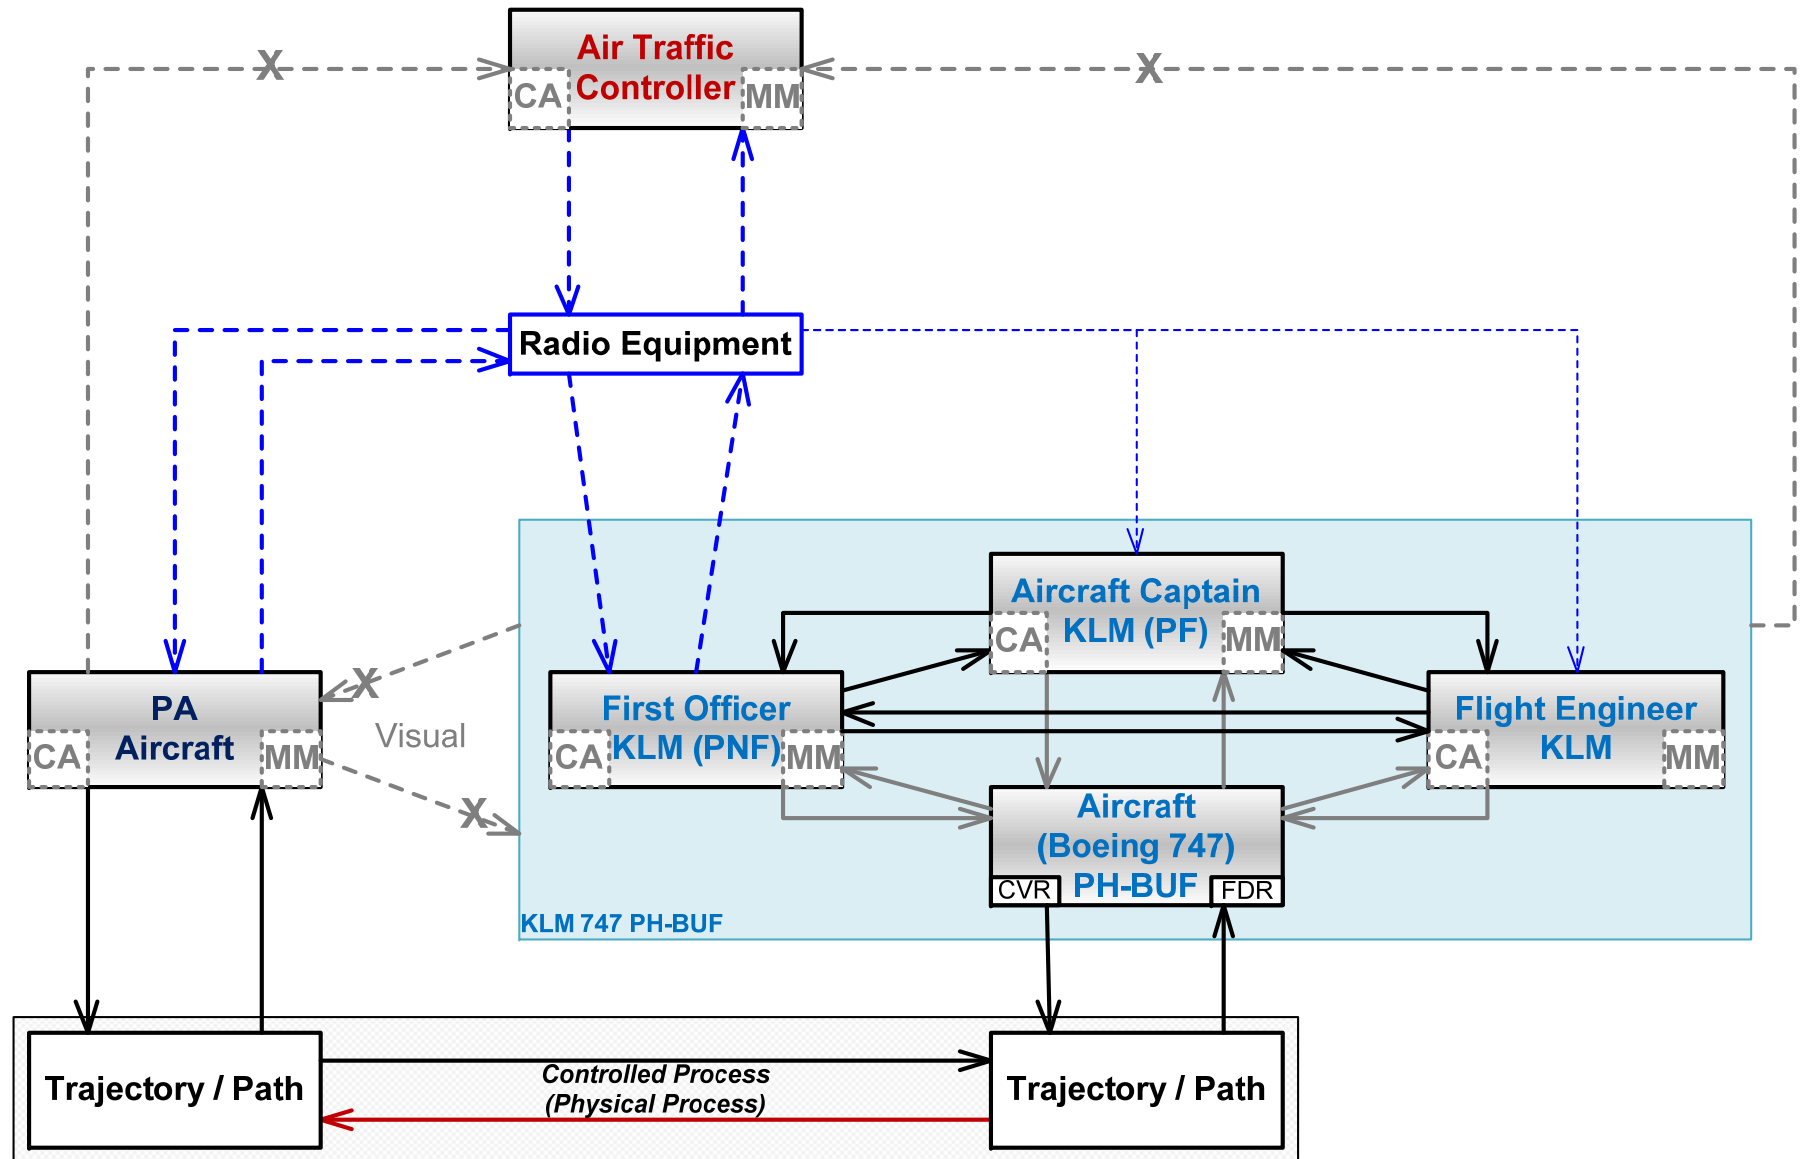
HCS: Casual Analysis

KLM Captain:
