Increasing Learning from Accidents: A Systems Approach Illustrated by the UPS Flight 1354 Birmingham Airport Accident

Shem Malmquist
Nancy Leveson
James Perry
Gus Larard
Darren Straker

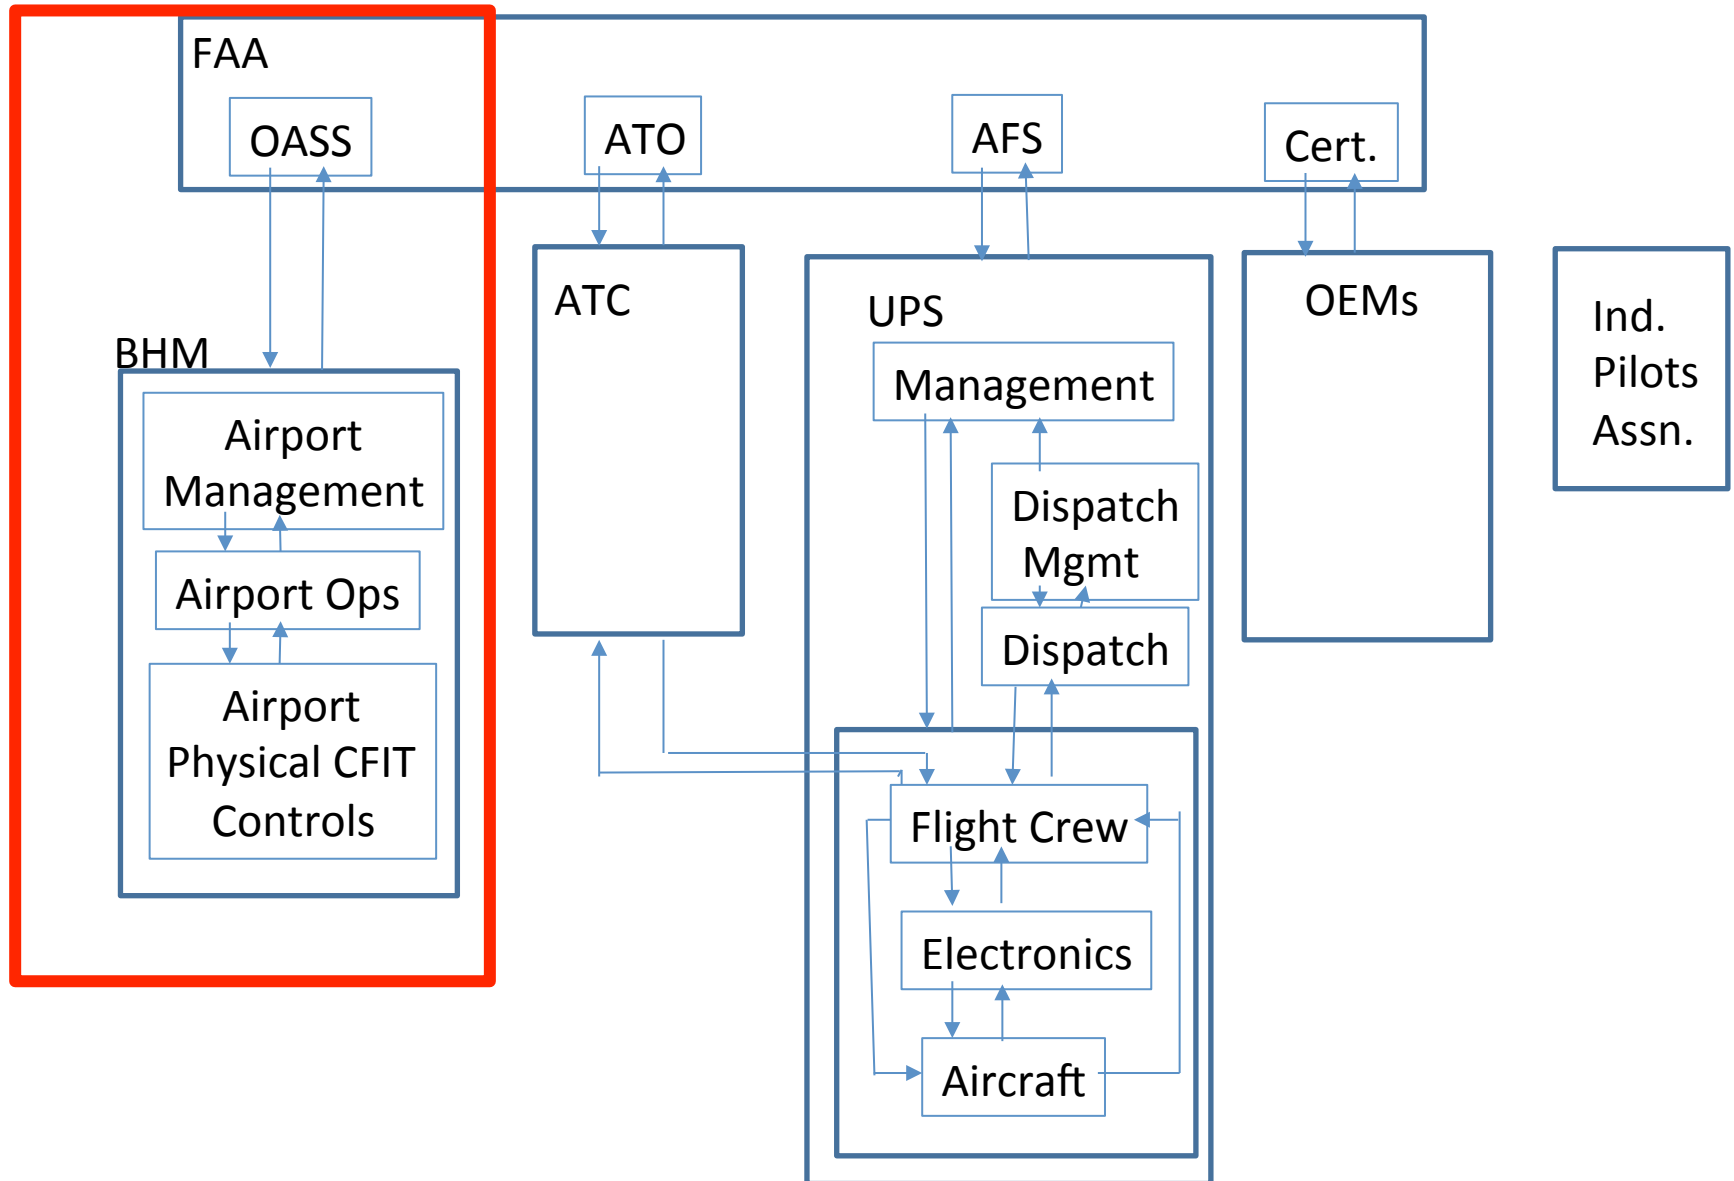
FAA Office of Airport Safety and Standards

<p>Birmingham Airport Authority</p>	<p>Role: Did not have ILS on all runways, probably for cost or feasibility reasons. Performed maintenance on the primary runway when large aircraft operations were scheduled to commence.</p> <p>Open Questions: Why was ILS maintenance scheduled during scheduled arrival times for large aircraft? Is as much weight put on cargo aircraft safety as passenger aircraft? When and what type of information was provided to the scheduled airlines about maintenance that night?</p> <p>Recommendations: Review criteria for scheduling maintenance and notifying airline dispatchers. Review criteria for installing precision approach equipment if there was not a good reason for the decision to omit it from the secondary runway.</p>
<p>FAA Office of Airport Safety and Standards</p>	<p>Role: Did not provide oversight on (1) the use of runways with navigational aids that are not appropriate for larger aircraft (2) the scheduling of maintenance on navigational aids during periods of scheduled arrivals, and (3) did not require methods in addition to NOTAMs to assure safety during maintenance outages.</p> <p>Recommendations: (1) Review criteria for installation of precision approach guidance at runways that are used for jet transport aircraft. (2) Review criteria allowing the flying of approaches to runways that use aids not designed for that size/type of aircraft.</p>

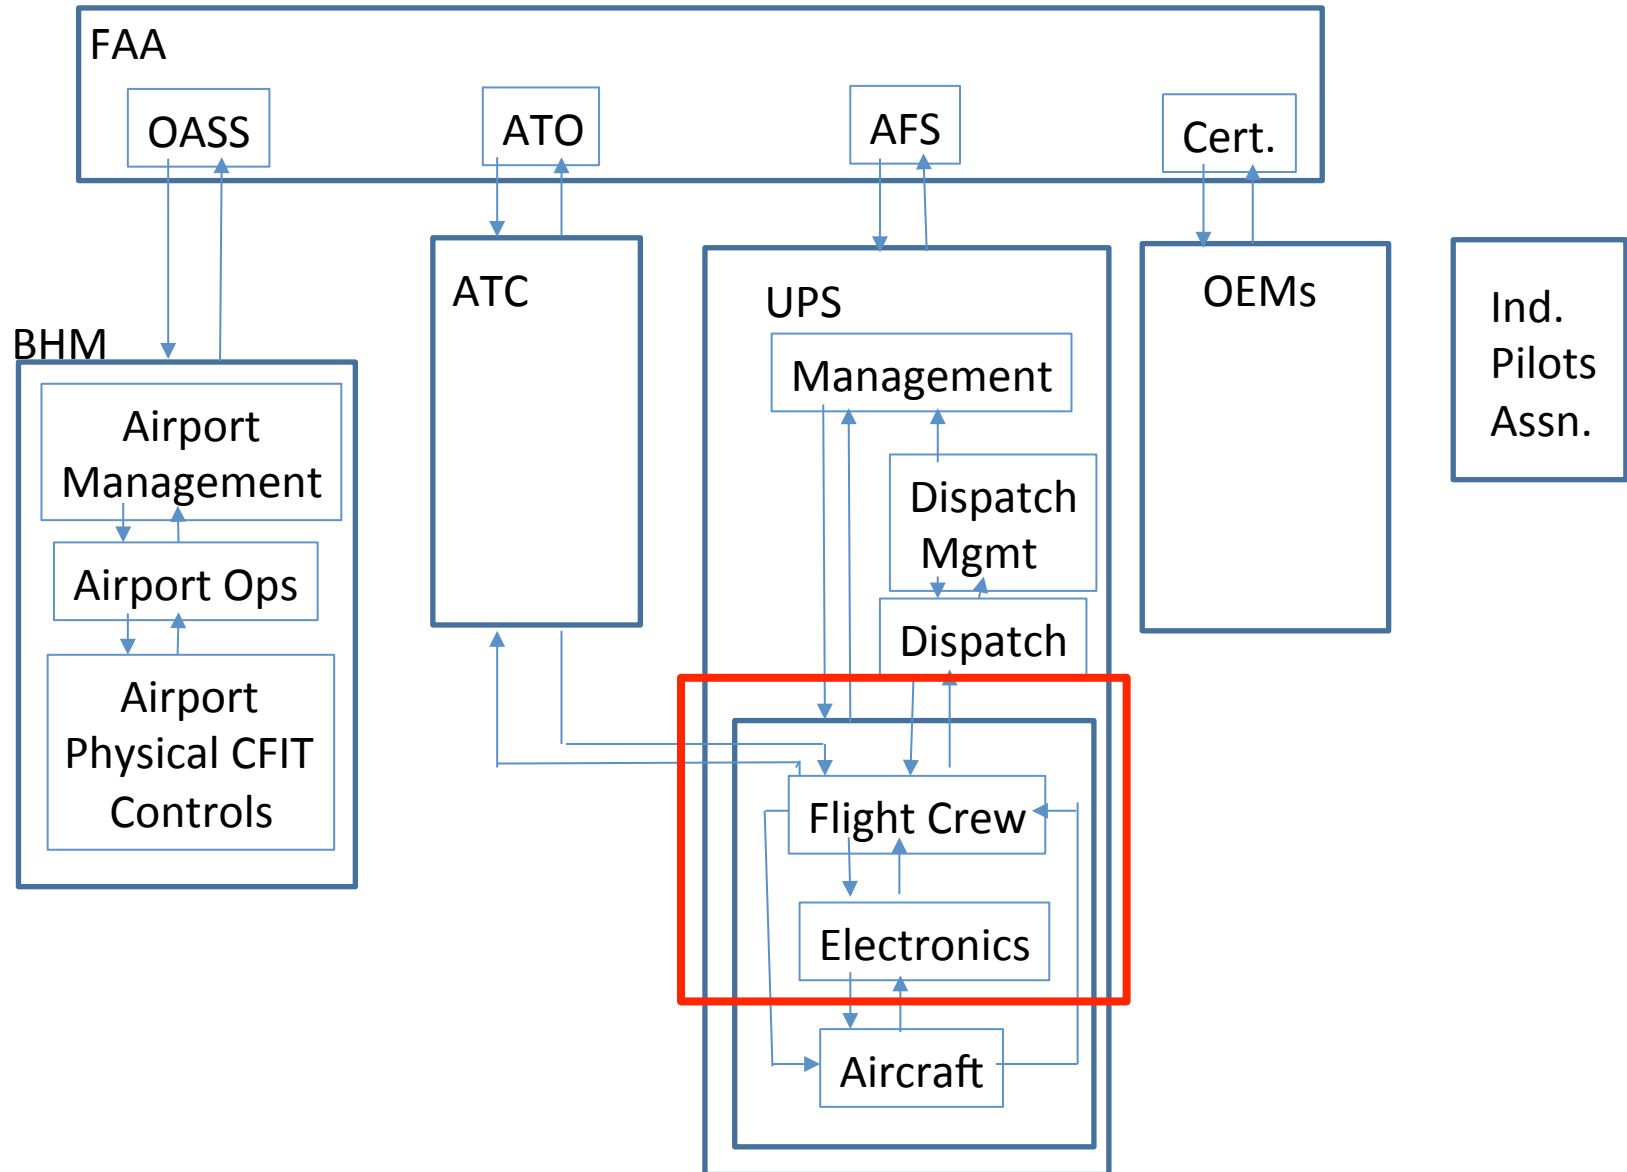
Flight crew - Electronics

Unsafe Control Action: Did not properly configure (program) the FMC for a profile approach. Did not call for pilot monitoring to verify the flight plan in the FMS.

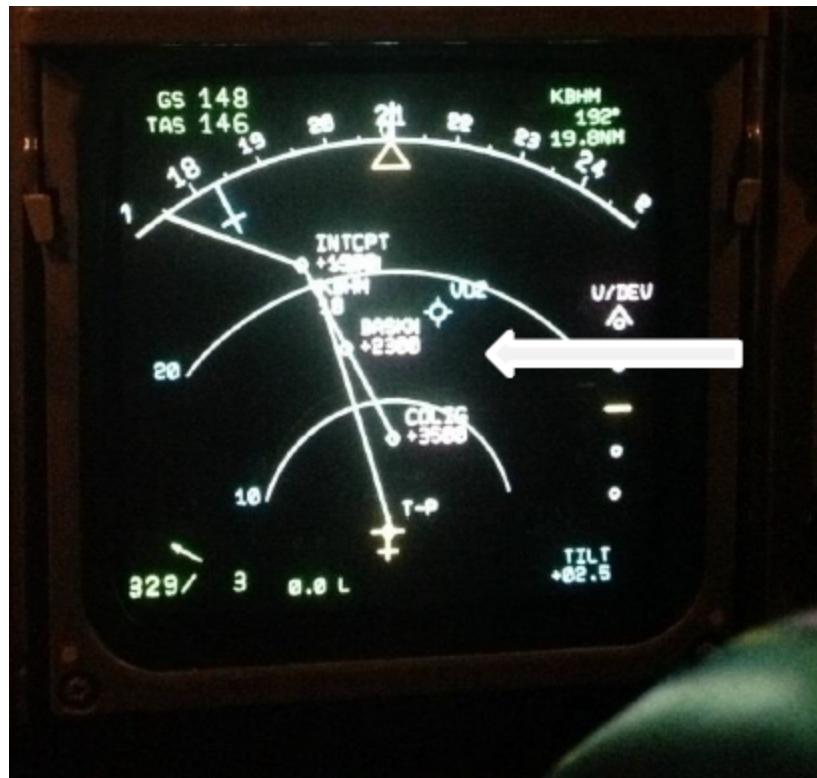
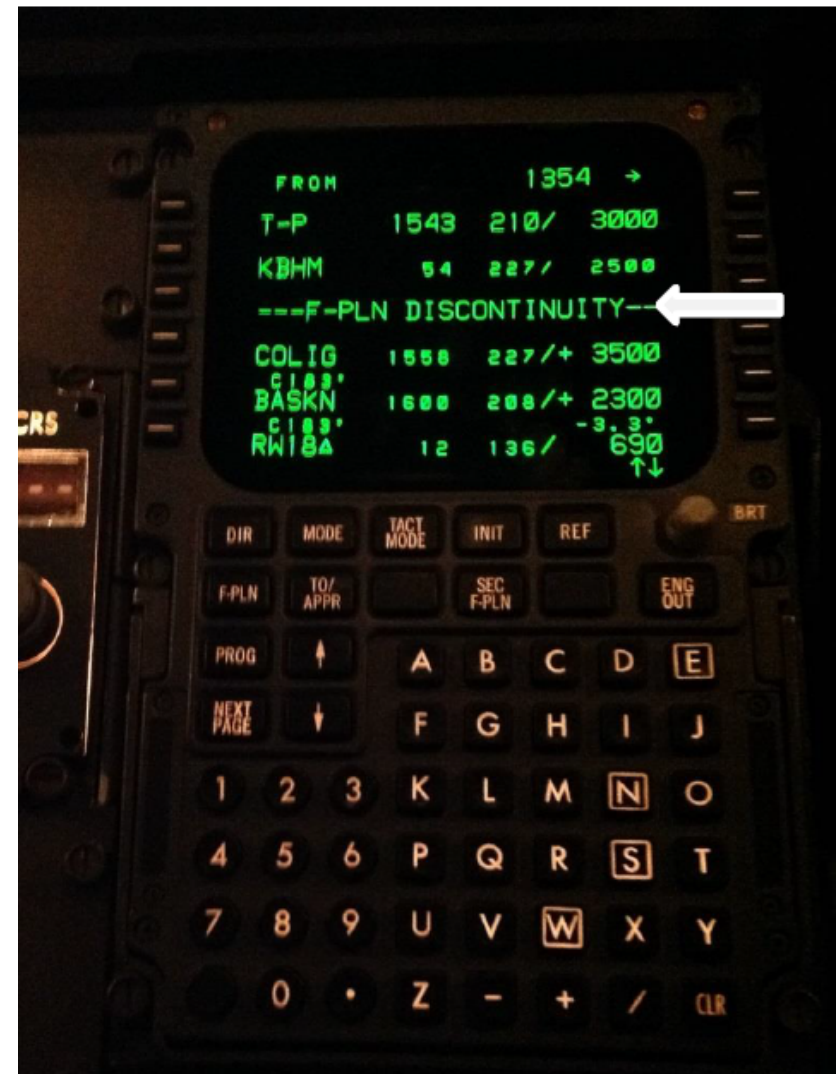
Unsafe Control Action: ND depiction showed aircraft on route even though points had not actually been sequenced.

Process Model Flaws	
Thought the aircraft was in the position displayed	
Context	Questions Raised

- As the LOC was providing lateral guidance the aircraft could still track the displayed final approach track despite the lack of waypoint sequencing.
