A System Theoretic Analysis of U.S. Coast Guard Aviation – CG-6505 Mishap

STAMP Workshop - 2013

CDR Jon Hickey
U.S. Coast Guard
MIT SDM 2012
March 26, 2013

Mishap Summary – CG-6505

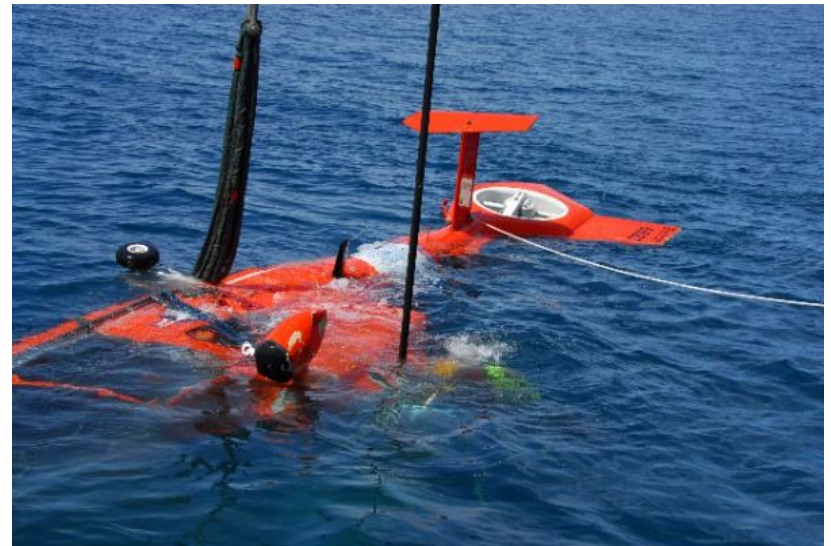
Causal Factor #1:

- Pilot Over-Control and Over-Torque
 - Approached too close to CG-47317
 - Over adjusted to compensate – commanded aircraft to climb away too fast

Related Contributing Factors:

- Poor visibility due to darkness
- Pilot misperception of operational conditions

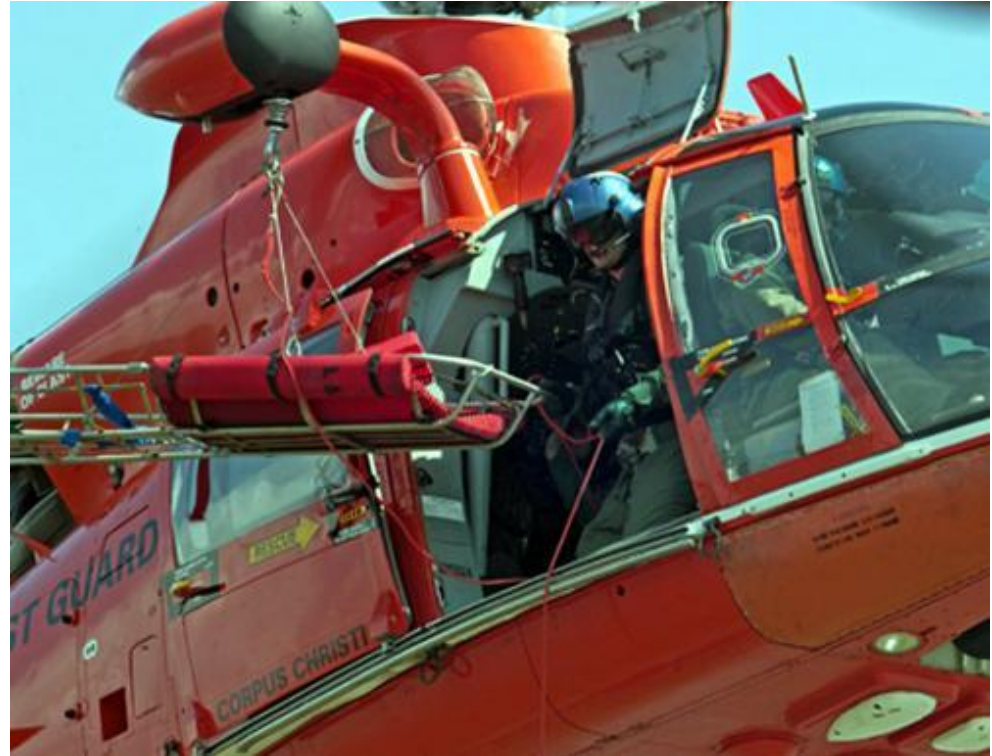
Causal Factor #2:

- Pilot Procedural Error – Failure to initiate “Hoist Cable Fouled/Damaged emergency procedures
 - Failure to pay out cable
 - Failure to shear cable

Related Contributing Factors:

- Poor visibility due to darkness
- Lack of hoist cable sensors/feedback
- Lack of system safety approach to CG asset design/acquisition.

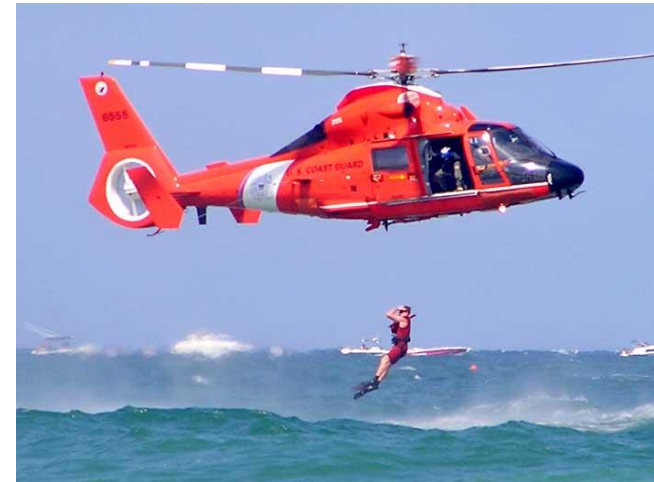
Accident Report Identified Causes (3 of 4) – CG-6505

Causal Factor #3:

- Pilot Procedural Error – Failure to initiate aircraft ditching emergency procedures
 - Failure to recognize/evaluate severe vibration post hoist cable parting
 - Failure to ditch aircraft

Related Contributing Factors:

- Poor visibility due to darkness – inability to see water surface/assess damage
- Loud vibration – impeded situational awareness, crew communications, etc.
- Aircraft crew’s attention too channelized on maintaining the aircraft versus analyzing the situation and taking appropriate action.
- Cultural instinct – Cultural imperative to “bring the crew and aircraft home.”
- Crew Team Leadership – Poor Crew Resource Management post hoist cable parting. Poor communications, lack of assertiveness, and failure to follow procedures.
- Organizational Training Issues – Lack of emphasis on ditching in pilot/crew development.

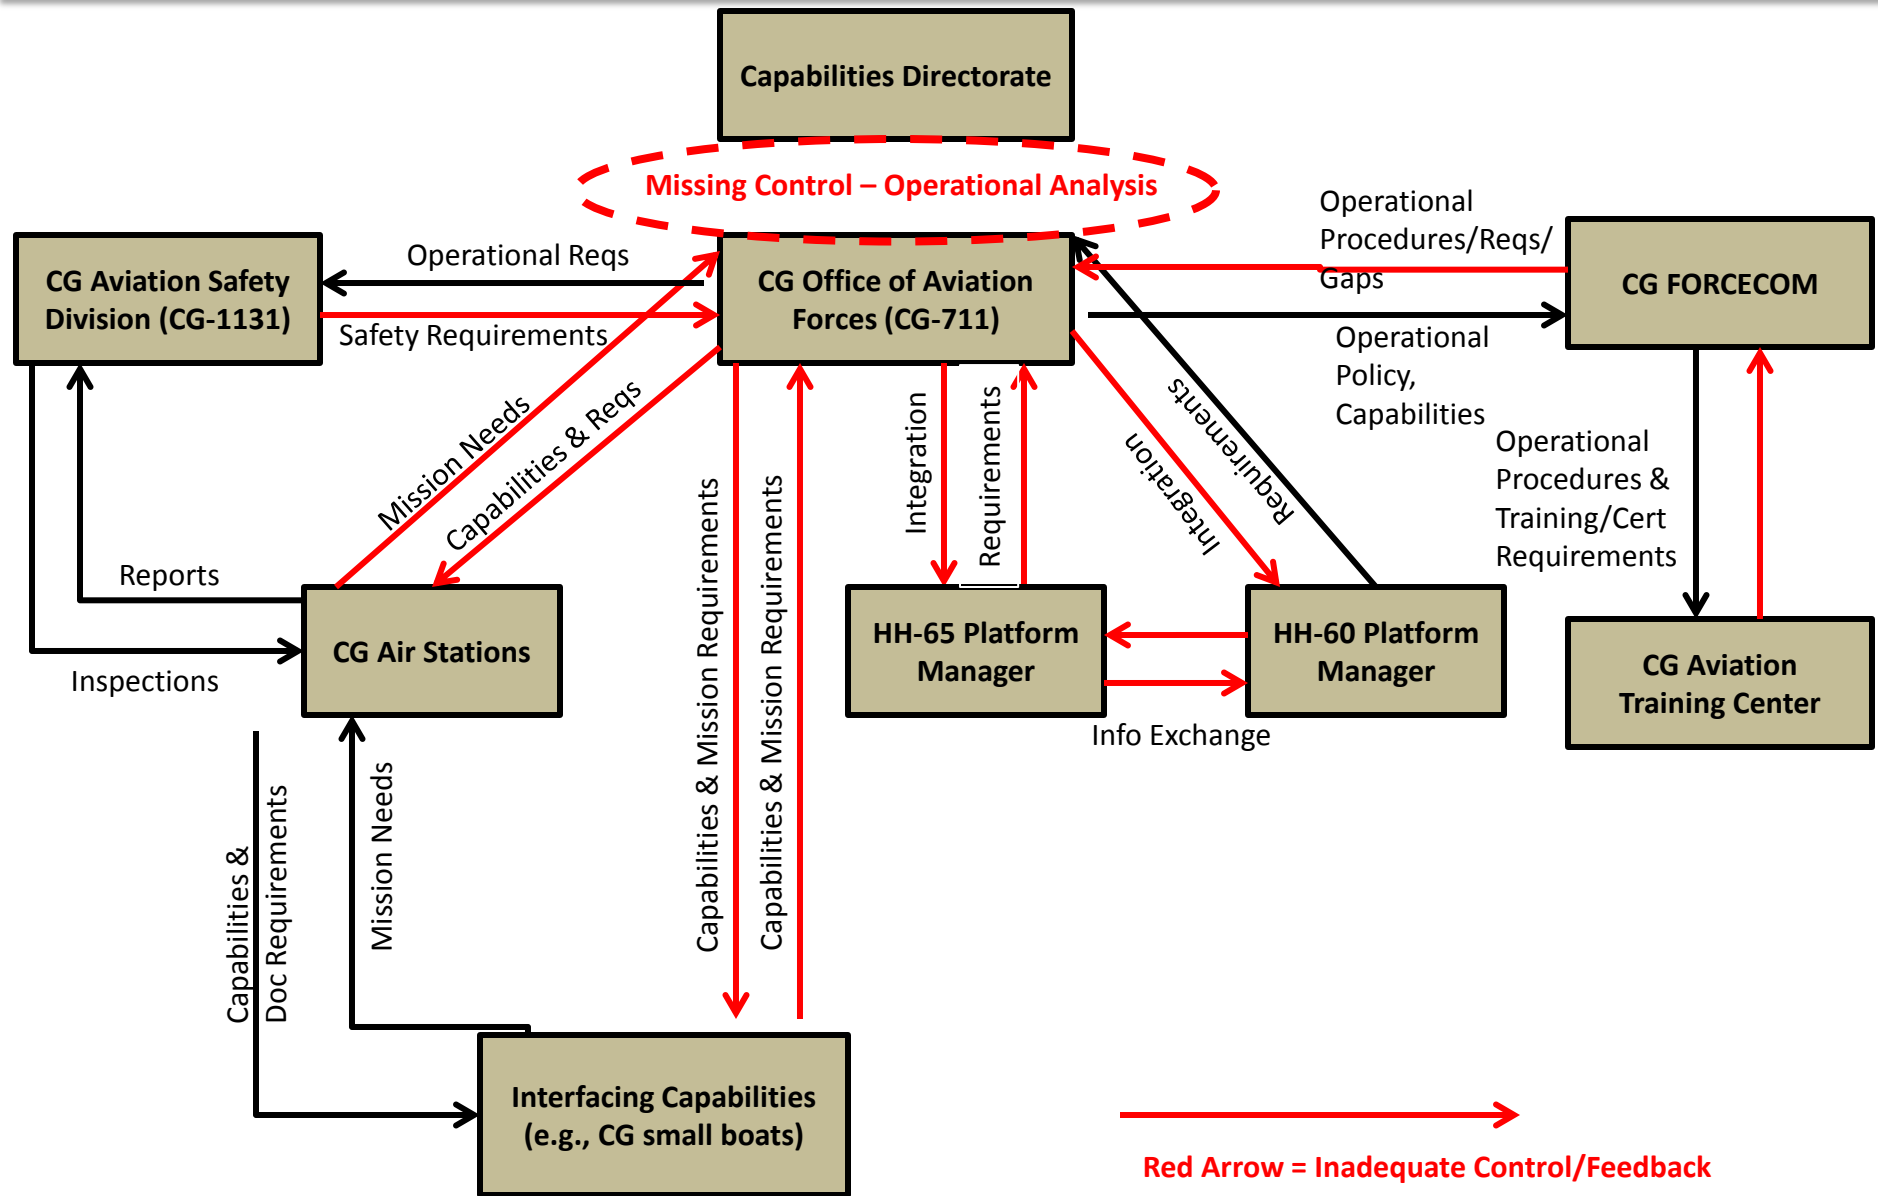
Capabilities Management – Control/Feedback Inadequacies

- **Inadequate communication/documentation of requirements & associated gaps up and down the aviation capabilities chain**
- **Inadequate sharing of information across platform managers**
- Inadequate sharing of information across industry
- **Inadequate review of existing capabilities (failure to follow policy)**
- Inadequate understanding/documentation of system interfaces
- **Inadequate leveraging of user info/lessons learned**
