Using STAMP to Learn from Chinese High Speed Railway Accident

Professor Tang Tao; Dr Niu Ru
State Key Lab. of Railway Traffic Control and Safety
Beijing Jiaotong University, China

Chinese High-speed Railway Accident

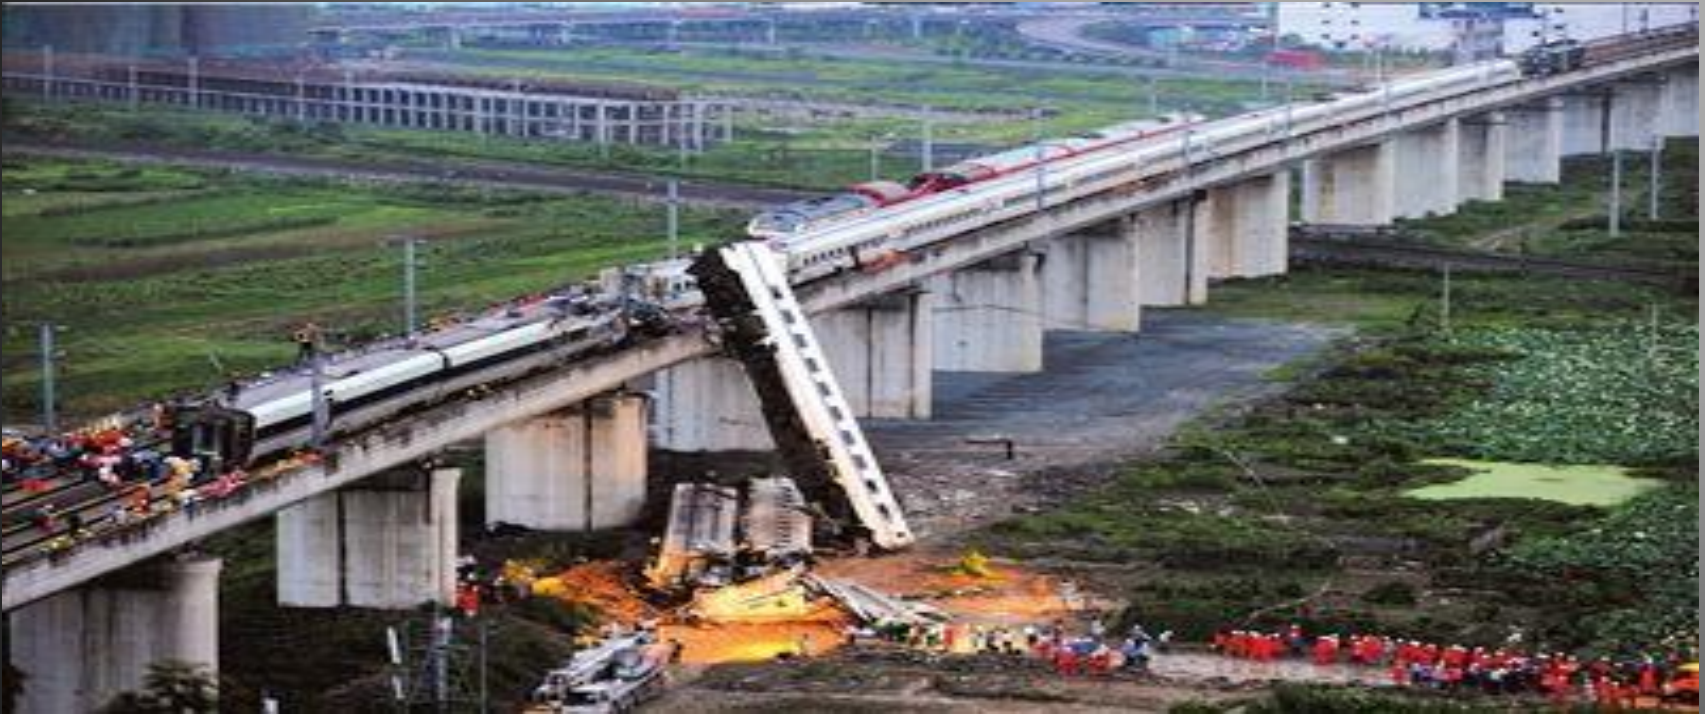
- ▶ On the 23 July 2011 at 20:30:05
- ▶ Two EMU train in same direction collided together
- ▶ Cause 40 deaths, 172 injuries, interruption of traffic for 32 hours and 35 minutes

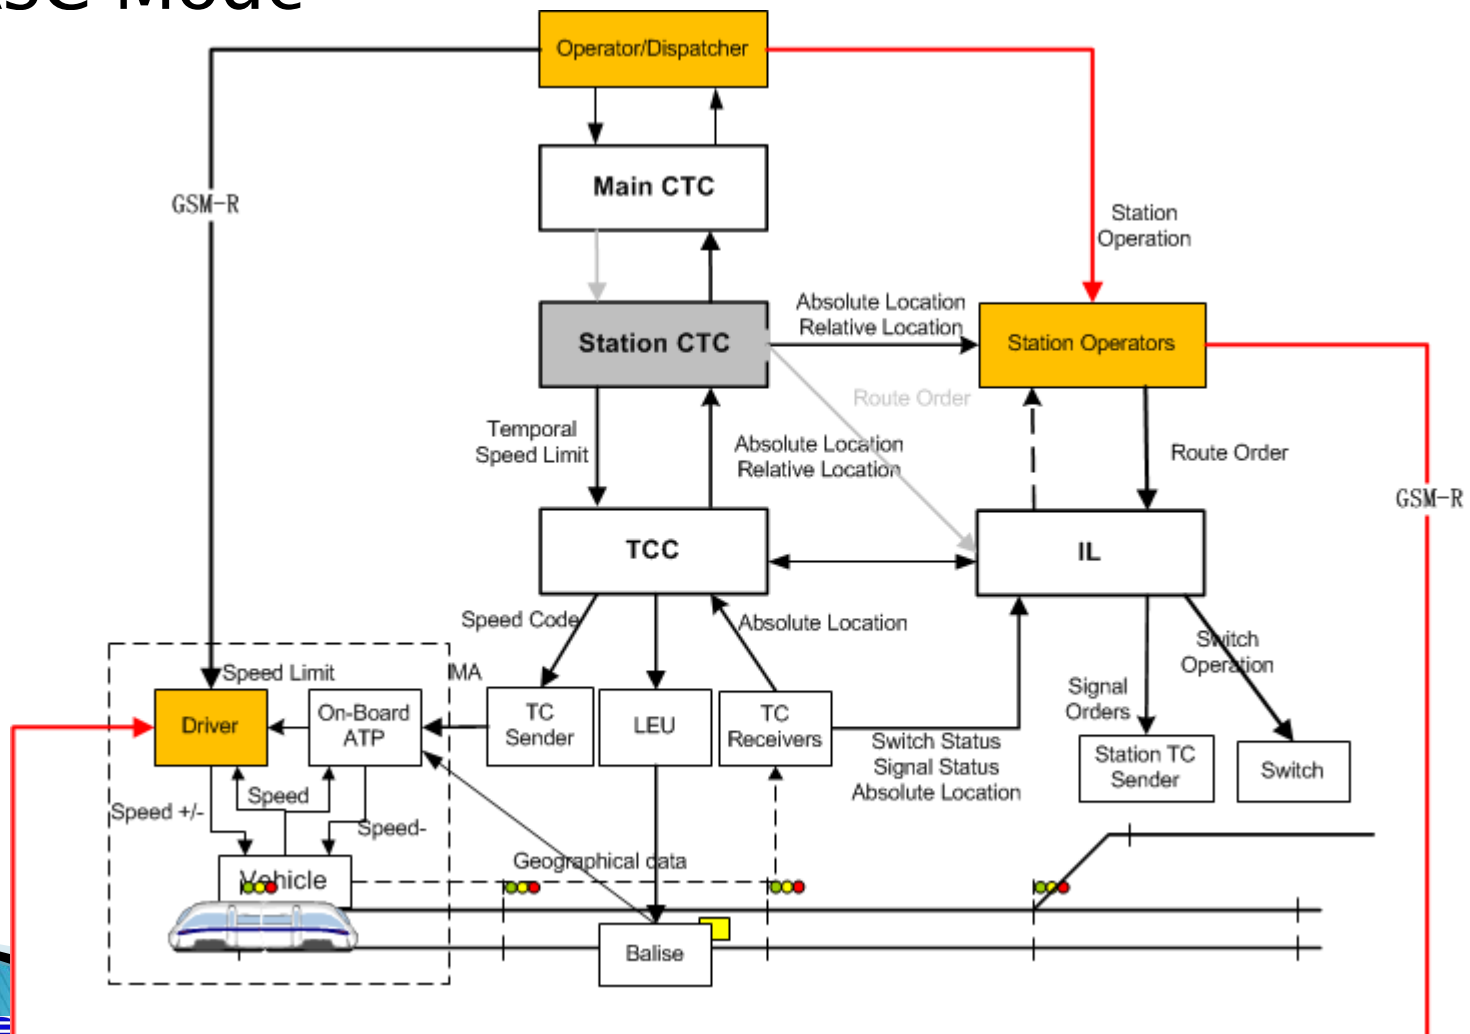
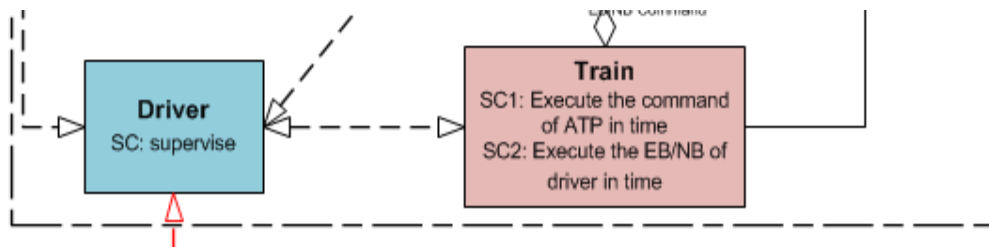
- ▶ **Violations**
 - TCC violate the SC, and generate unsafe MA;
 - The statuses of the section under control failed to update.
- ▶ So, SW error of TCC is the main reason of this accident.
- ▶ And, the power supply circuit obviously do not have the responsibility to ensure any of these two SCs.
- ▶ The GSM-R communication are not hazard control channels.

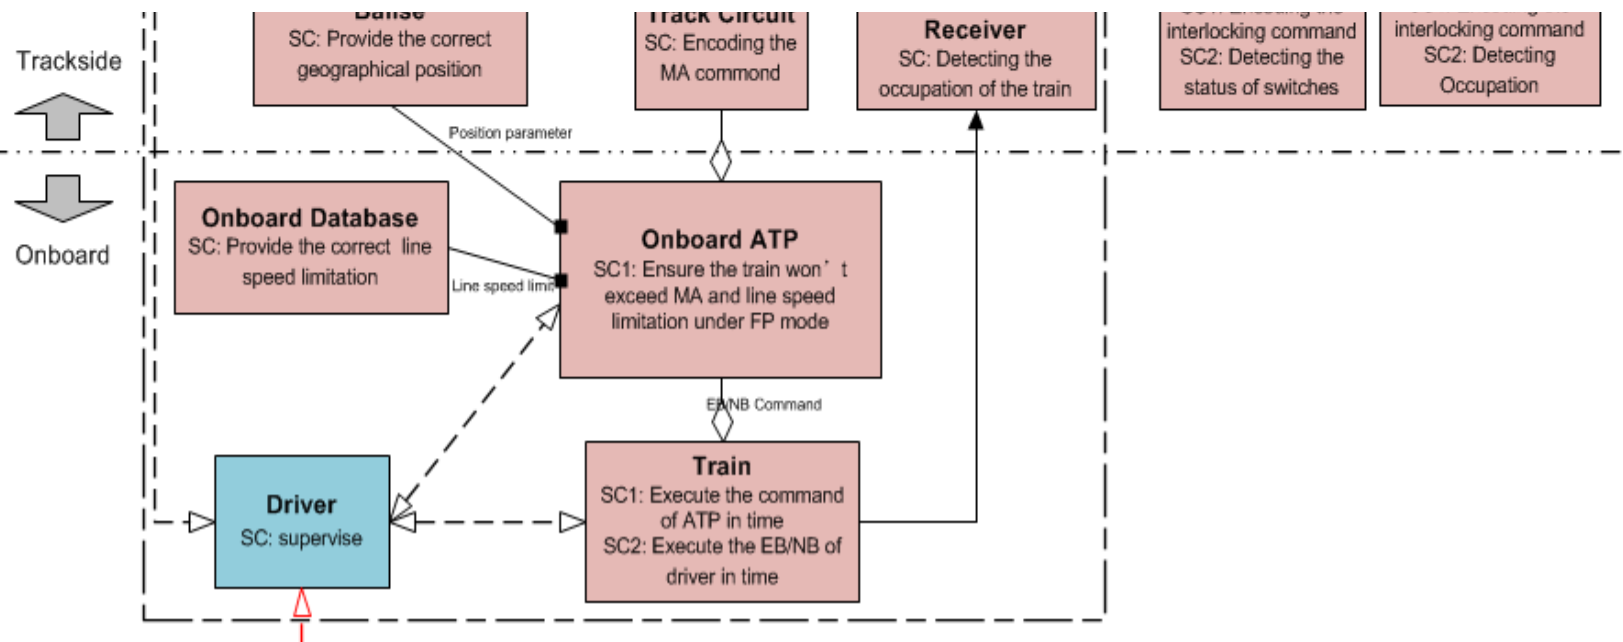
Violation

- The statuses of the section under control failed to update.
- ▶ Still, the same sw error..., which shows degraded to ASC mode was a improper decision.

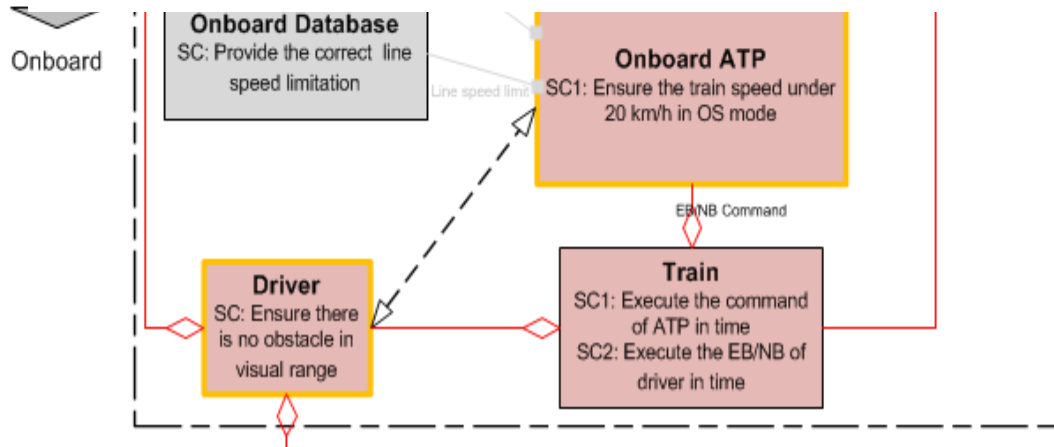
▶ Violation

- None!!

- ▶ So, D3115(front train) failed to move out 5829AG in time is a misunderstanding of the accident, and any improvement suggestions resulted from this are not practical.

- ▶ And, even now, there is no SC for the QoS of GSM-R Channels.

- More dependable diagnosis process should be used
 - Add TCCs handover checking
 - Add warning function in CTC to inform the dispatchers
 - Add consistency checking function of IL and TCC route data. (too complex to carry out)
- Give more training to maintainers to explicit the signaling system is not absolutely fail-safe any more.
- Redefine the emergency trigger scheme.
