CAST Analysis of the International Space Station EVA 23 Suit Water Intrusion Mishap

STAMP Workshop 2018

Akshay Kothakonda
Massachusetts Institute of Technology

March 28, 2018

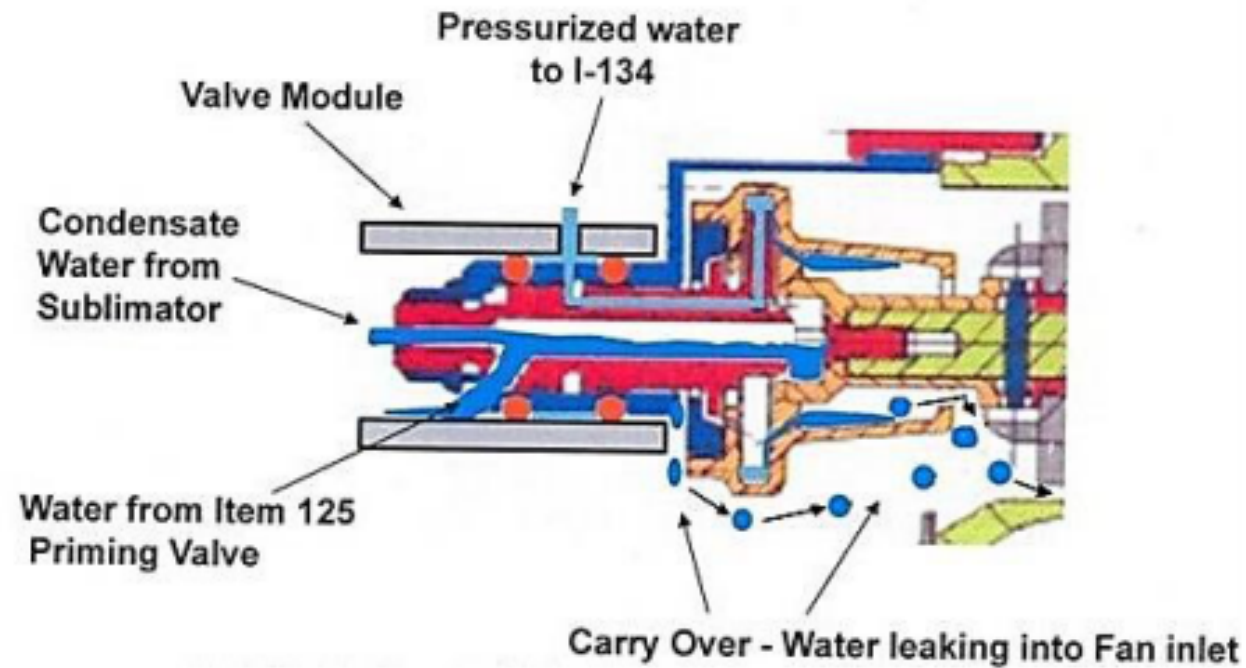
Water Separator Spinning Drum and Pitot Components

- **Mishap was found to be due to inorganic materials** blocking the drum holes in the EMU water separator, resulting in water spilling into the vent loop
