Increasing Learning from Accidents: A Systems Approach Illustrated by the UPS Flight 1354 Birmingham Airport Accident

Shem Malmquist
Nancy Leveson
James Perry
Gus Larard
Darren Straker

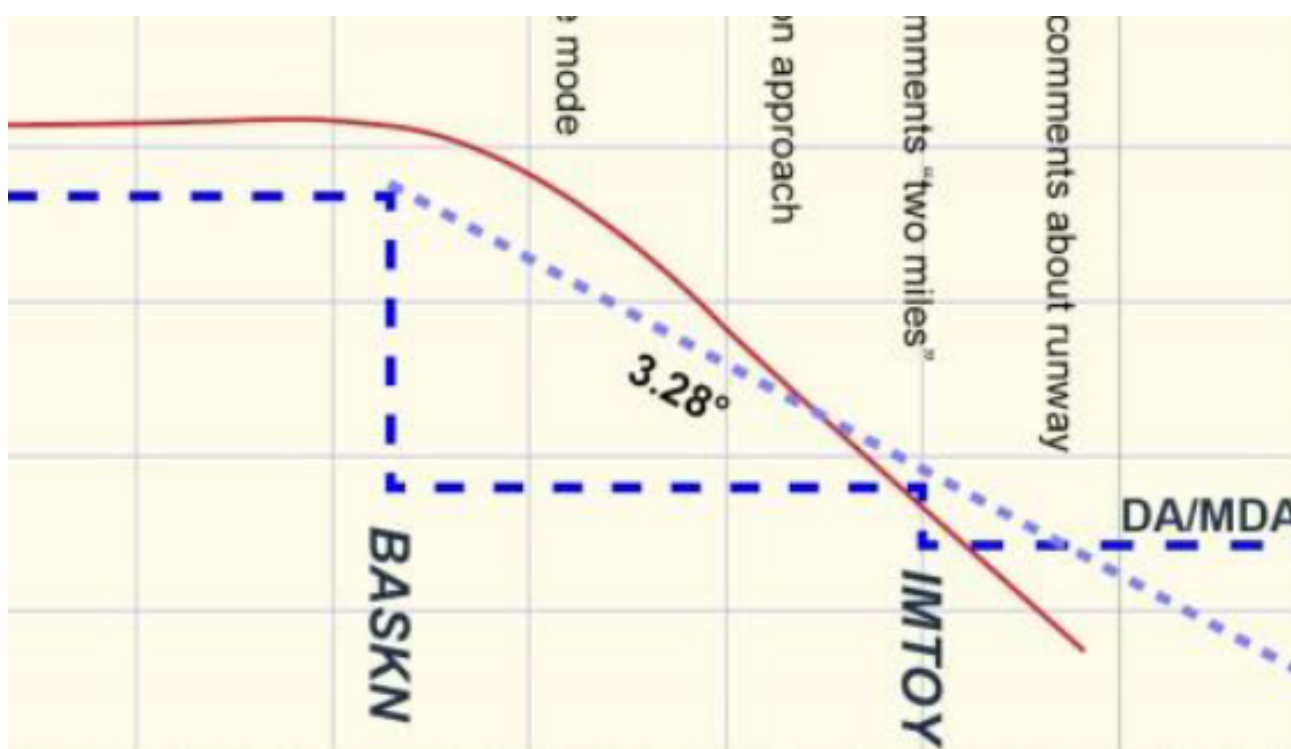
- About 7 seconds after the first officer completed the Before Landing checklist, the first officer noted that the captain had switched the autopilot to vertical speed mode; shortly thereafter, the captain increased the vertical descent rate to 1500 fpm.

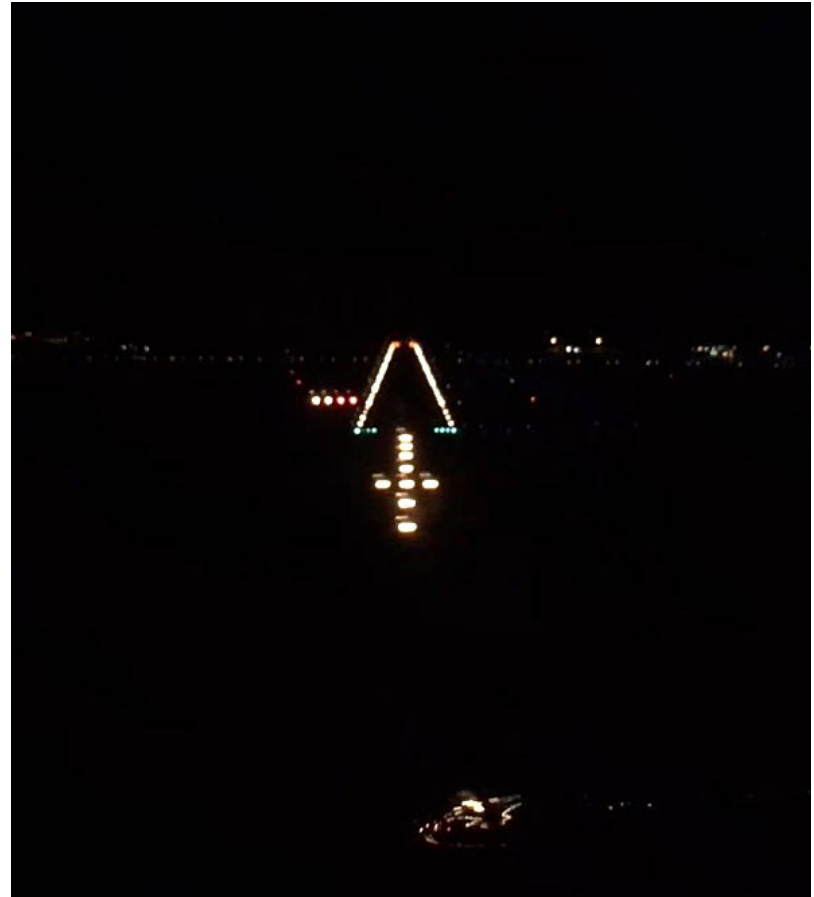
- The airplane continued to descend.
- At 1000 ft msl (about 250 ft above ground level, an enhanced ground proximity warning system (EGPWS) “sink rate” caution alert was triggered.
- The captain began to adjust the vertical speed in accordance with UPS’s trained procedure.
- He reported the runway in sight about 3.5 seconds after the “sink rate” caution alert.
- Airplane continued to descend at a rate of about 1000 fpm.

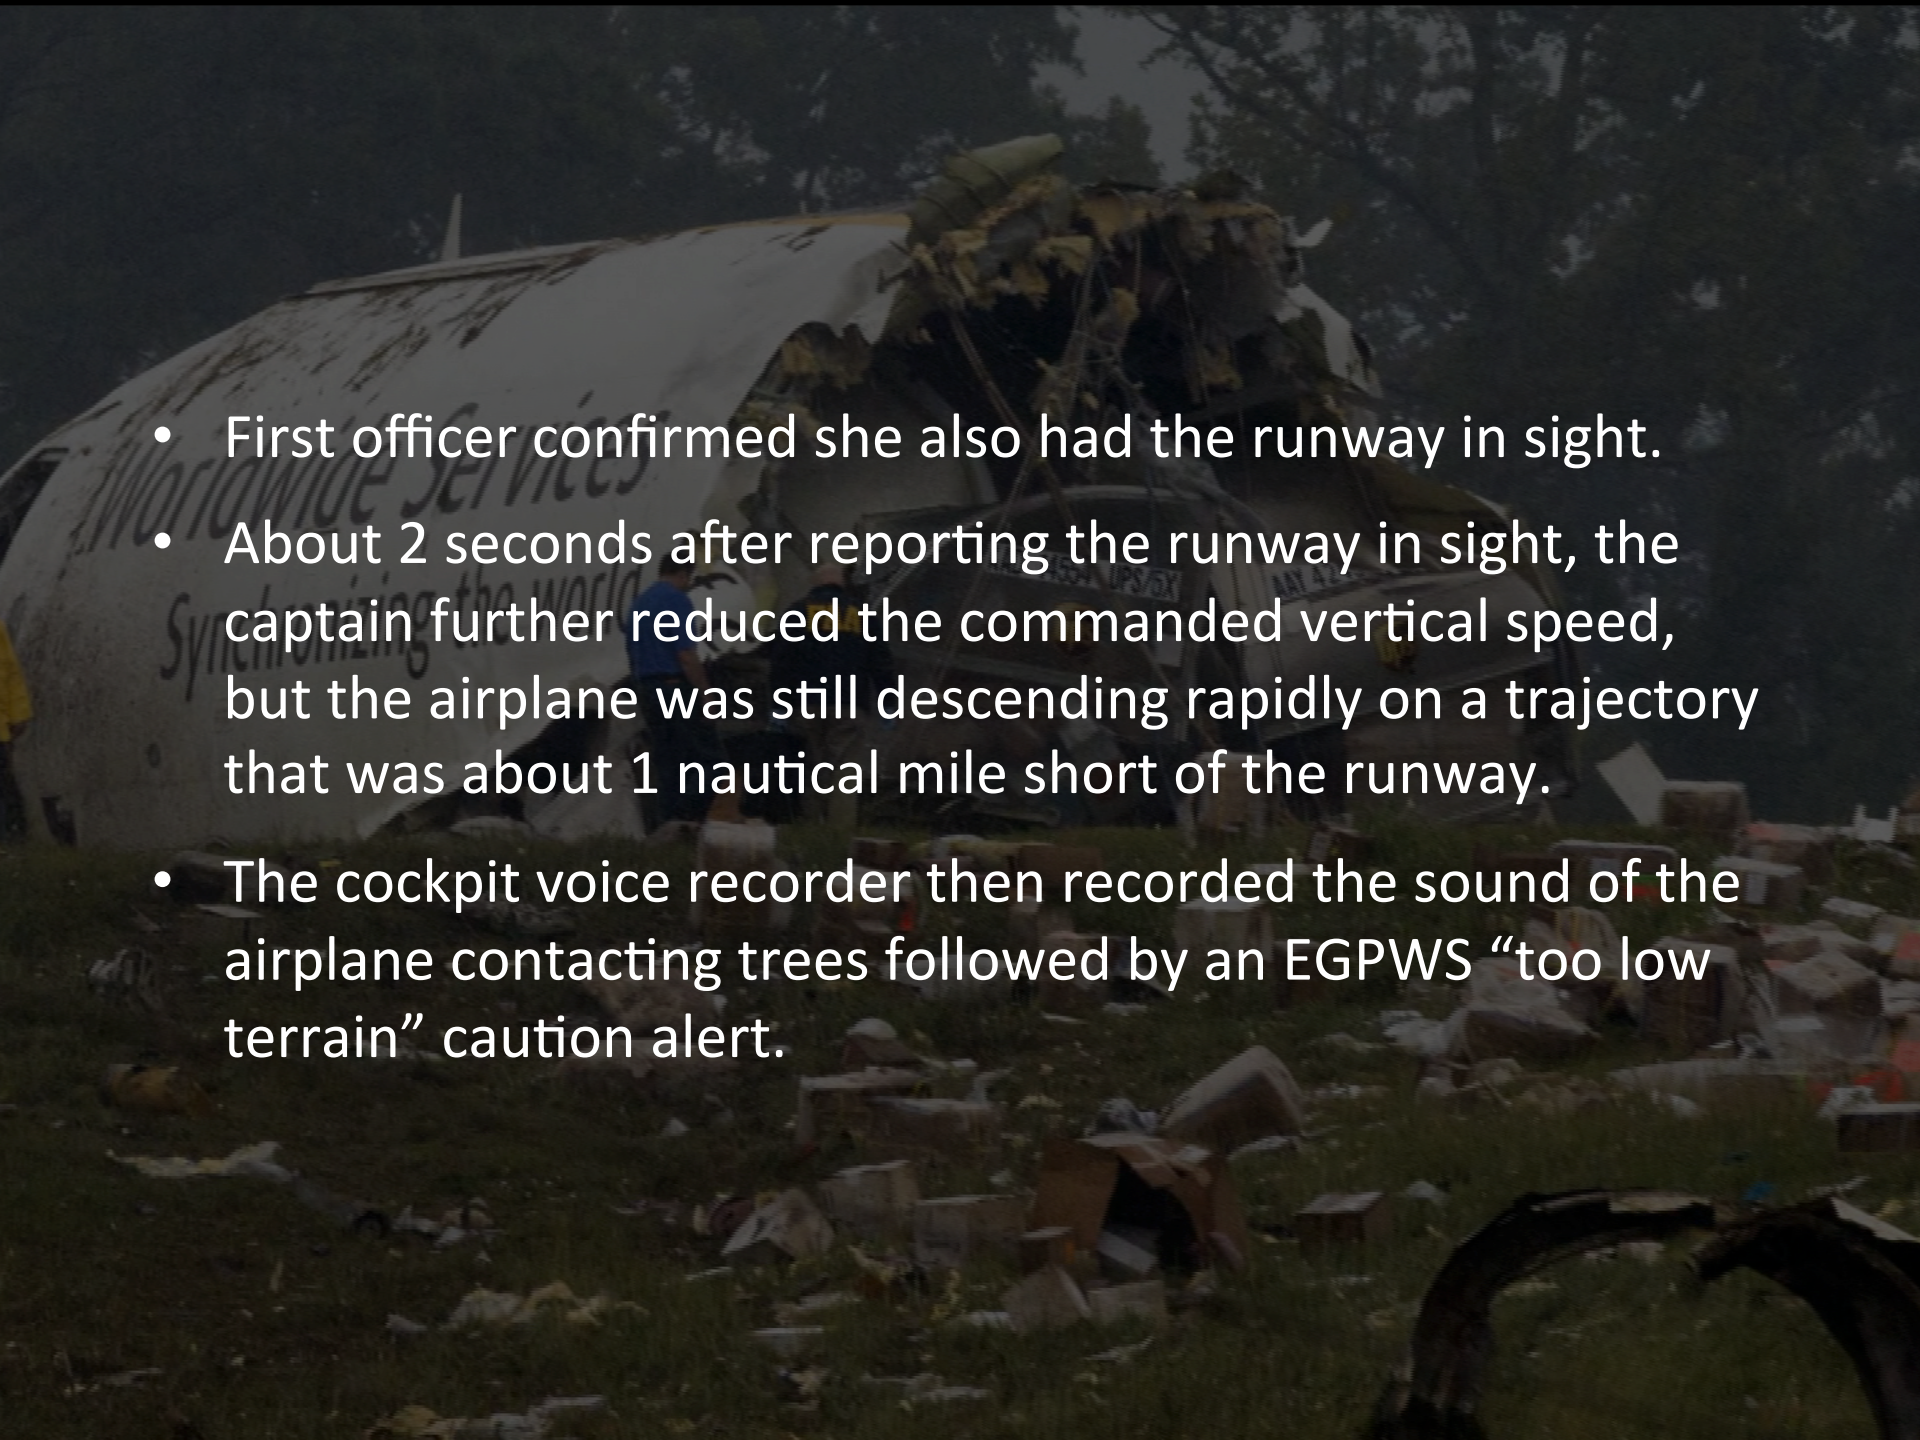
- First officer confirmed she also had the runway in sight.
 - About 2 seconds after reporting the runway in sight, the captain further reduced the commanded vertical speed, but the airplane was still descending rapidly on a trajectory that was about 1 nautical mile short of the runway.
 - The cockpit voice recorder then recorded the sound of the airplane contacting trees followed by an EGPWS “too low terrain” caution alert.

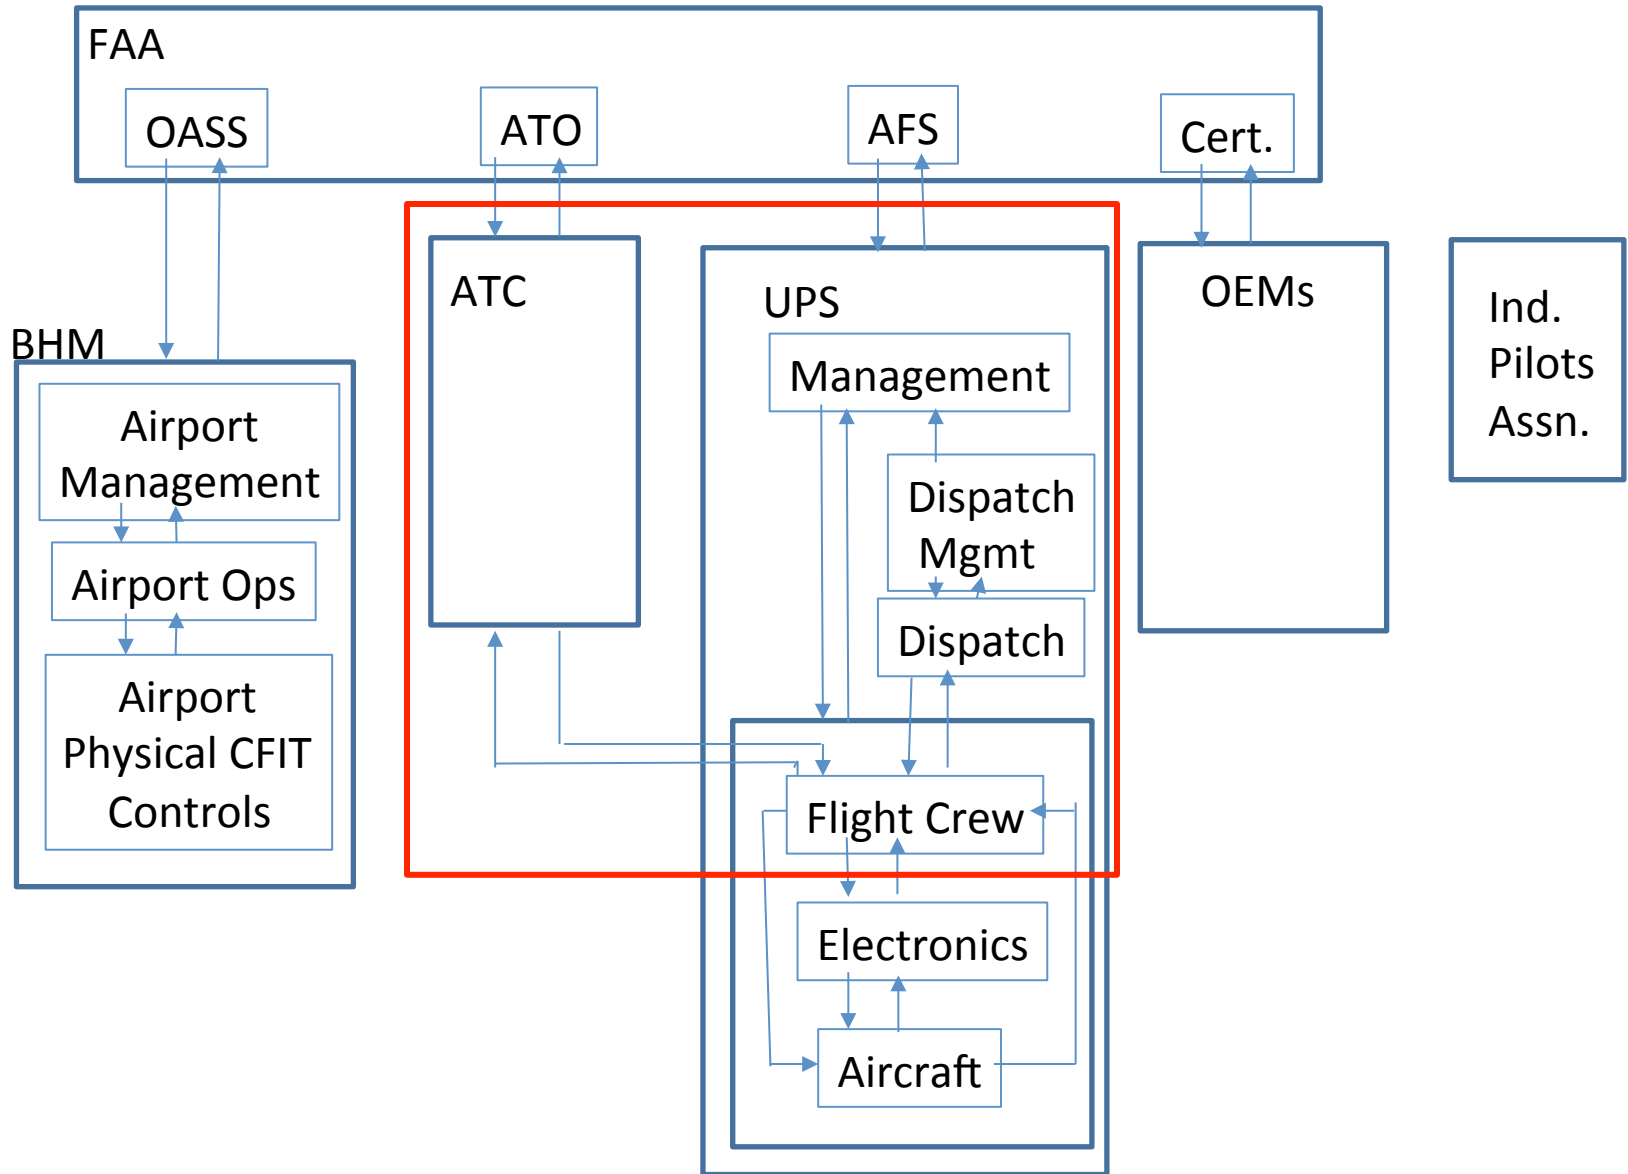
Contextual factors example

How did flight end up flying the LOC?

From Pilot interactions

- Crew missed NOTAM

From pilot interactions

- LOC approach shown earlier in charting sequence

From ATC-Pilot interactions

- Controller offered it

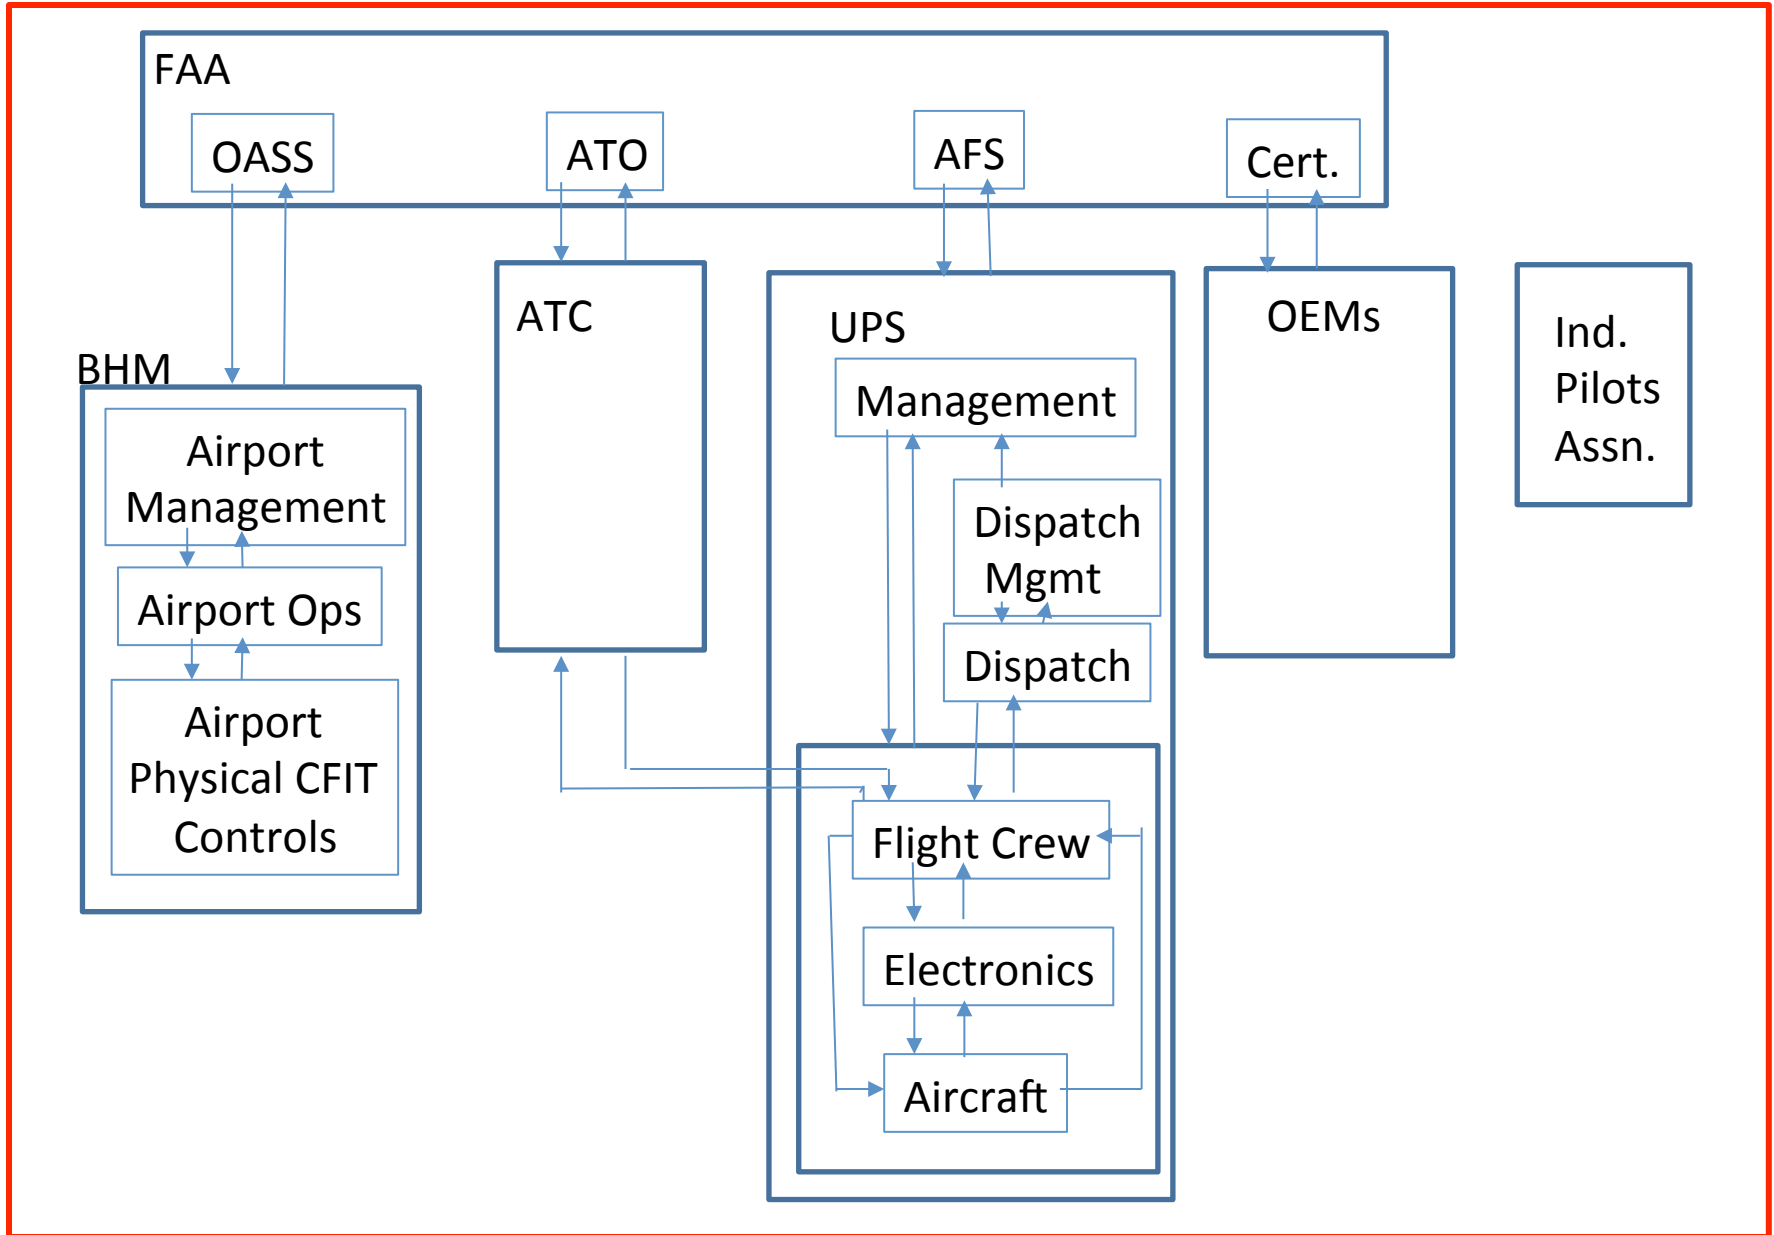
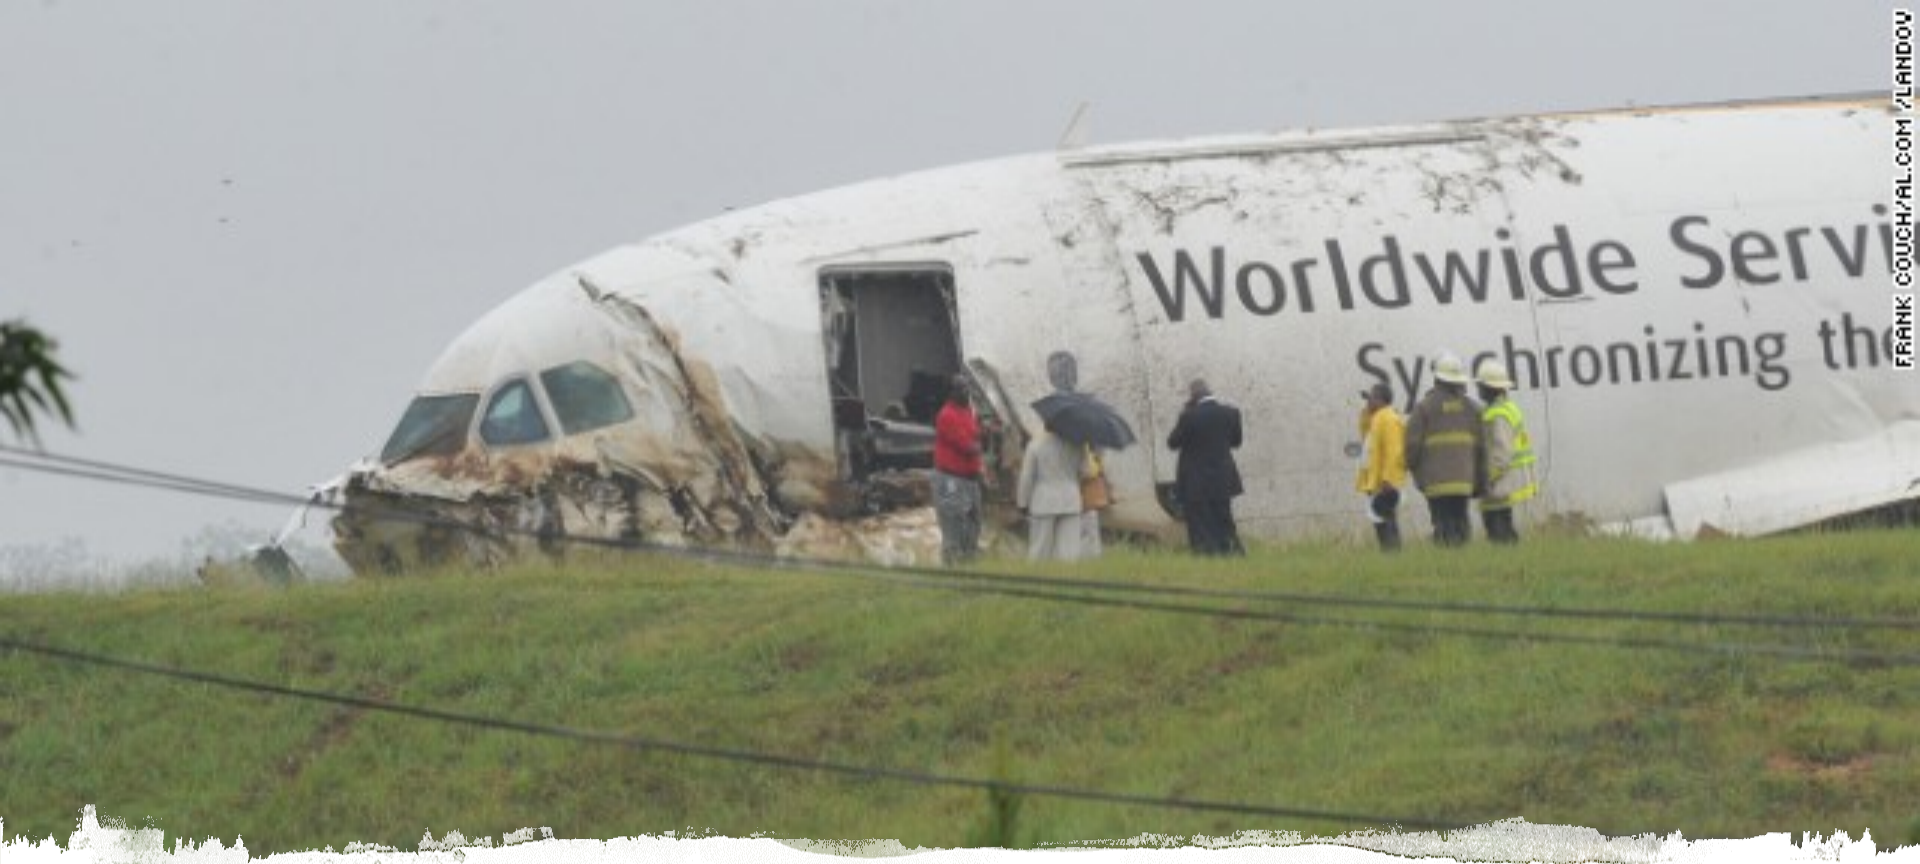
Systemic factors

- Safety Culture (cargo pilots)
- Safety information system
- Dynamics and change over time
- Communication and Coordination among controllers

- FAA and cargo aircraft pilot associations should investigate whether the actions of the cargo operator industry has led to more suspicion and less trust by the pilots of those carriers.
- The FAA and cargo aircraft pilot associations should institute a study of whether cargo aircraft are treated differently by airports and whether any differences result in higher risk for cargo aircraft.

- Identify and implement changes to the information system to ensure that accurate weather information is available when needed and to those who need it.
- The FAA and other industry groups should study whether the increase in cargo operations has changed or increased the level or types of hazards such that they are no longer adequately mitigated by current procedures and controls.
- Subject changes in the provision of critical information to a hazard analysis.
