Using STAMP to Learn from Chinese High Speed Railway Accident

Professor Tang Tao; Dr Niu Ru
State Key Lab. of Railway Traffic Control and Safety
Beijing Jiaotong University, China

Chinese High-speed Railway Accident

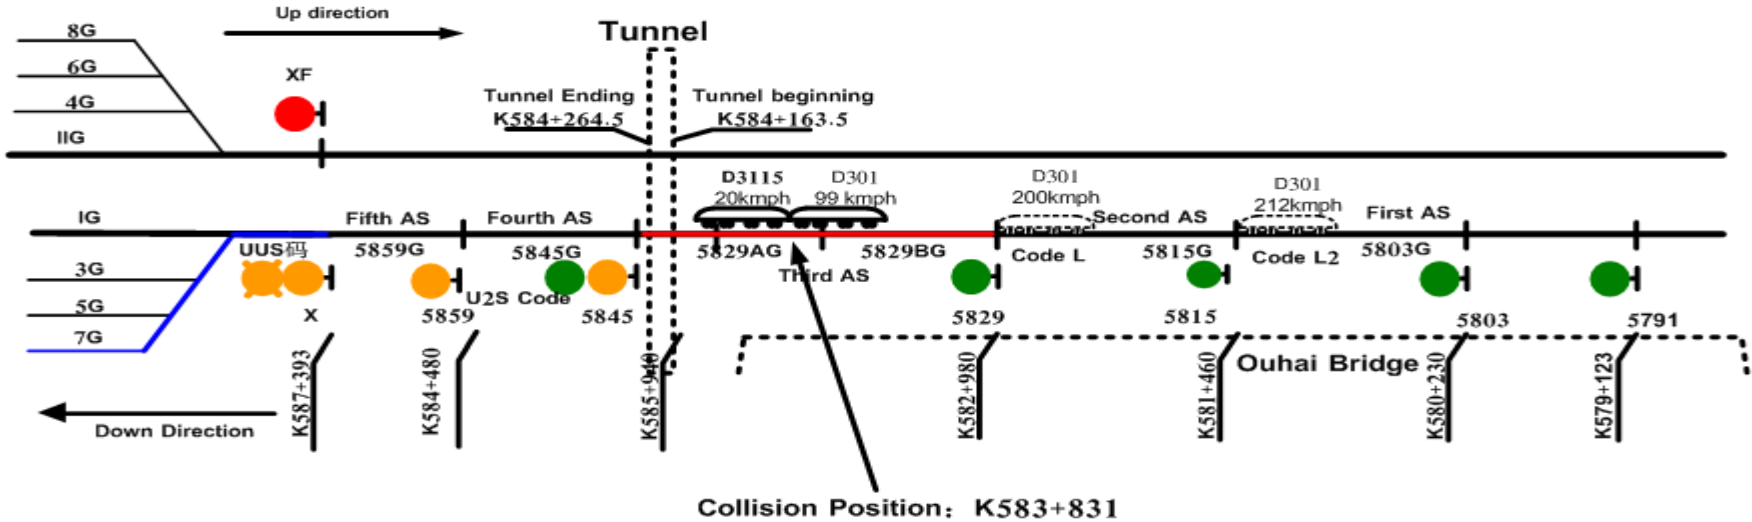
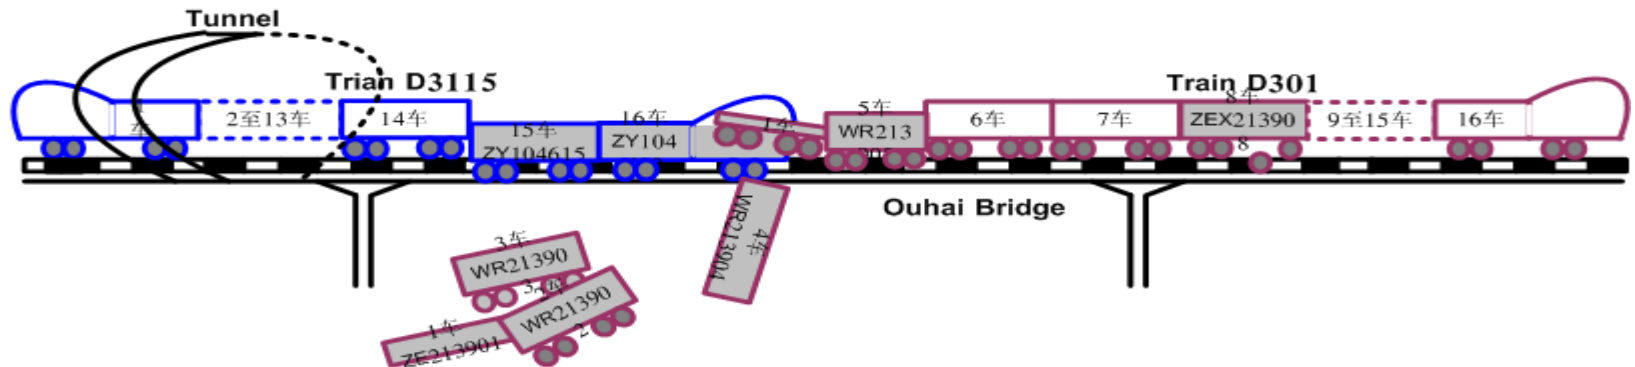
Wenzhou South Station

- ▶ On the 23 July 2011 at 20:30:05
- ▶ Two EMU train in same direction collided together
- ▶ Cause 40 deaths, 172 injuries, interruption of traffic for 32 hours and 35 minutes
