# Dams as Systems

Pat Regan

Federal Energy Regulatory Commission  
(FERC)

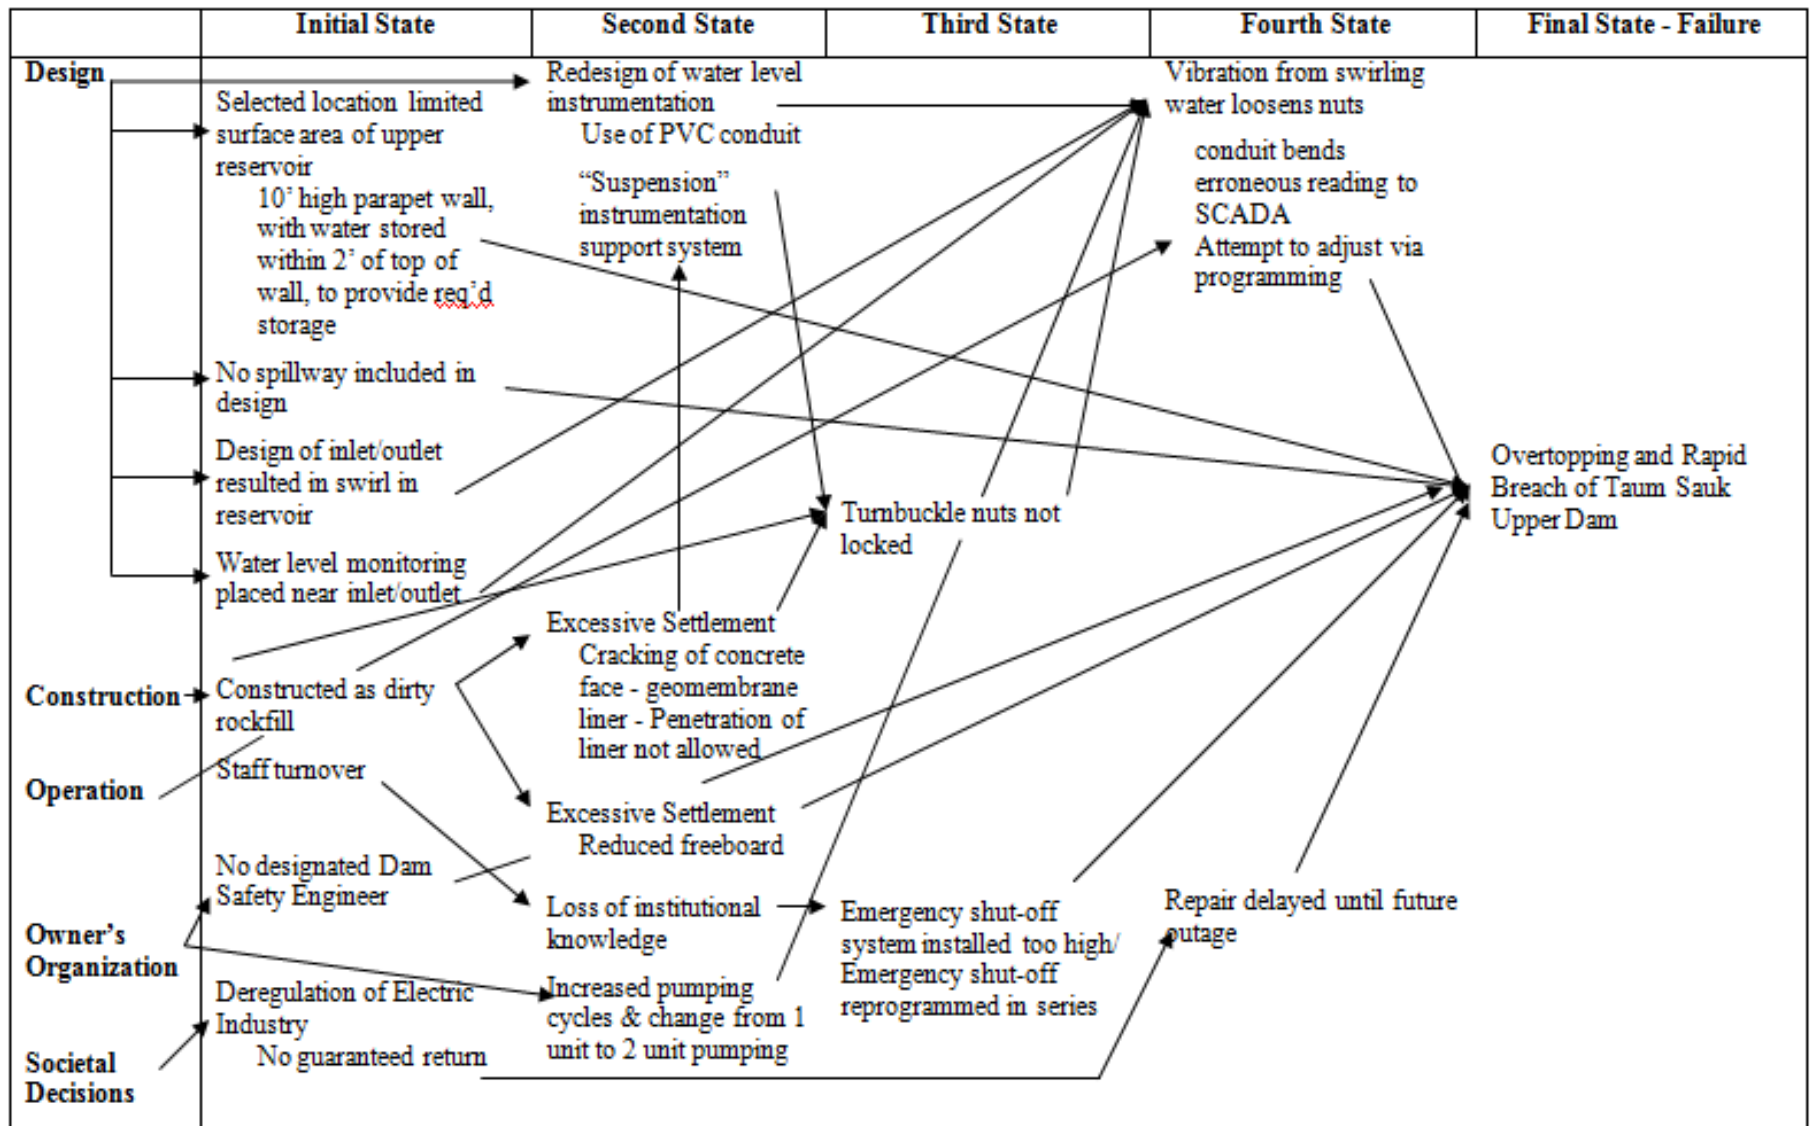
Figure 2 – Interaction Flow Chart – Taum Sauk Upper Dam Failure

Phase						
	Design	Initial Construction	Operation State 1 (1963-1990)	Operation State 2 (1990s)	“Remediation” (2004)	Operation State 3	Failure
Design	<p>Location limited surface area of reservoir. Needed storage volume required 10’ high parapet wall with 8’ of water stored against wall</p> <p>Assumed clean rockfill</p> <p>No spillway included</p> <p>Emergency shut-off system includes high water alarm (alarm in PH) and high-high alarm (shuts off pumps at 1’ remaining freeboard)</p> <p>Water level monitoring equipment placed near “morning glory” inlet-outlet works (shortest distance to PH)</p>	<p>Dirty Rockfill at best, rocky earthfill in some areas</p> <p>Instrumentation firmly fastened to concrete upstream face</p>	<p>Excessive settlement (~1’ in 4.5 years)</p> <p>Water flow causes vortex development at inlet-outlet</p>	<p>Continuing settlement, up to ~2’, results in cracking of concrete face slab and mis-alignment of parapet wall resulting in excessive seepage through dam</p>	<p>Geomembrane liner installed on upstream face to reduce seepage</p> <p>Penetration of liner not allowed. Instruments supported from top of dam to bottom by “suspension” system. Turnbuckle nuts not locked</p> <p>PVC conduit houses instruments</p> <p>Emergency shut-off system installed at “design” elevations (ignoring the 2’ of settlement that had taken place)</p>	<p>Vibration from vortices loosens nuts on instrument support system</p> <p>PVC conduit bends due to vortices thereby giving erroneous water levels</p>	<p>On December 14, 2005, at about 0510 the dam overtopped during a pumping operation. The water level alarms did not sound because both alarms had to trigger to sound an alarm (after being rewired in parallel) and the high-high water alarm was about two feet higher than the lowest point on the wall (due to ignoring the settlement). Due to the lack of a spillway the parapet wall overtops. The water falls 10’ onto the earthen embankment rapidly eroding the material and undermining the parapet wall. The wall overturns unleashing a 10’ wall of water that rapidly erodes the remaining embankment. It took only about 12 minutes to drain the reservoir. Peak outflow was estimated at 289,000 cfs (more than the Mississippi River above its confluence with the Ohio River). Luckily a downstream park and campground was empty due the time of year and 5 people in a house survived even though the house was swept from its foundation.</p>

Operation	<p>1-2 pump cycles per week</p> <p>One unit used to pump</p>		<p>Experienced local operating staff</p> <p>Operations staff adjust water level controls to account for settlement</p>	<p>Profit driven operation</p> <p>Remote operation</p> <p>Pump-turbines replaced, 25% greater capacity (1999)</p> <p>Multiple pump cycles/day</p> <p>Two unit pumping</p>		<p>High water and high-high water level instruments re-wired in parallel to eliminate “false” readings</p> <p>Operators reprogram computer to “account” for deflection of conduits</p> <p>Overtopping events on Sept. 25 and 27, 2005</p>	
Organization	<p>No person designated to assure dam safety</p>		<p>Adjustment of water level controls not documents</p> <p>Arrogance - (letter to a FPC engineer) “<b>I told him there would be no structural damage if the pumps failed to shut down</b>”. (1968)</p>	<p>Retirement of experienced staff</p> <p>Loss of institutional knowledge</p> <p>No one considers impact of changed operation</p>		<p>Repair to water level conduits delayed until future planned outage to minimize impact on generation</p>

Societal Decisions	<p>Rate of Return cost structure</p>			<p>Deregulation of electric industry (~1997). No guaranteed rate of return</p>

- It is our conclusion that the **root cause** of “*the uncontrolled, rapid release of water from the Upper Reservoir*” was the breach of the Rockfill Dike—a stability failure at the northwest corner of the Reservoir brought on by a rapid increase in the pore pressure at the Dike/foundation interface, stemming from the original design and construction which was flawed.
