CASTANALYSIS

LEARJET35AACCIDENTINSAOPAULO

“Apply CAST to the analysis of an accident in order to understand how it works and generate better recommendations for the brazilian aviation system.”

Our Case: The 2007 PT-OVC Learjet 35A crash in Sao Paulo

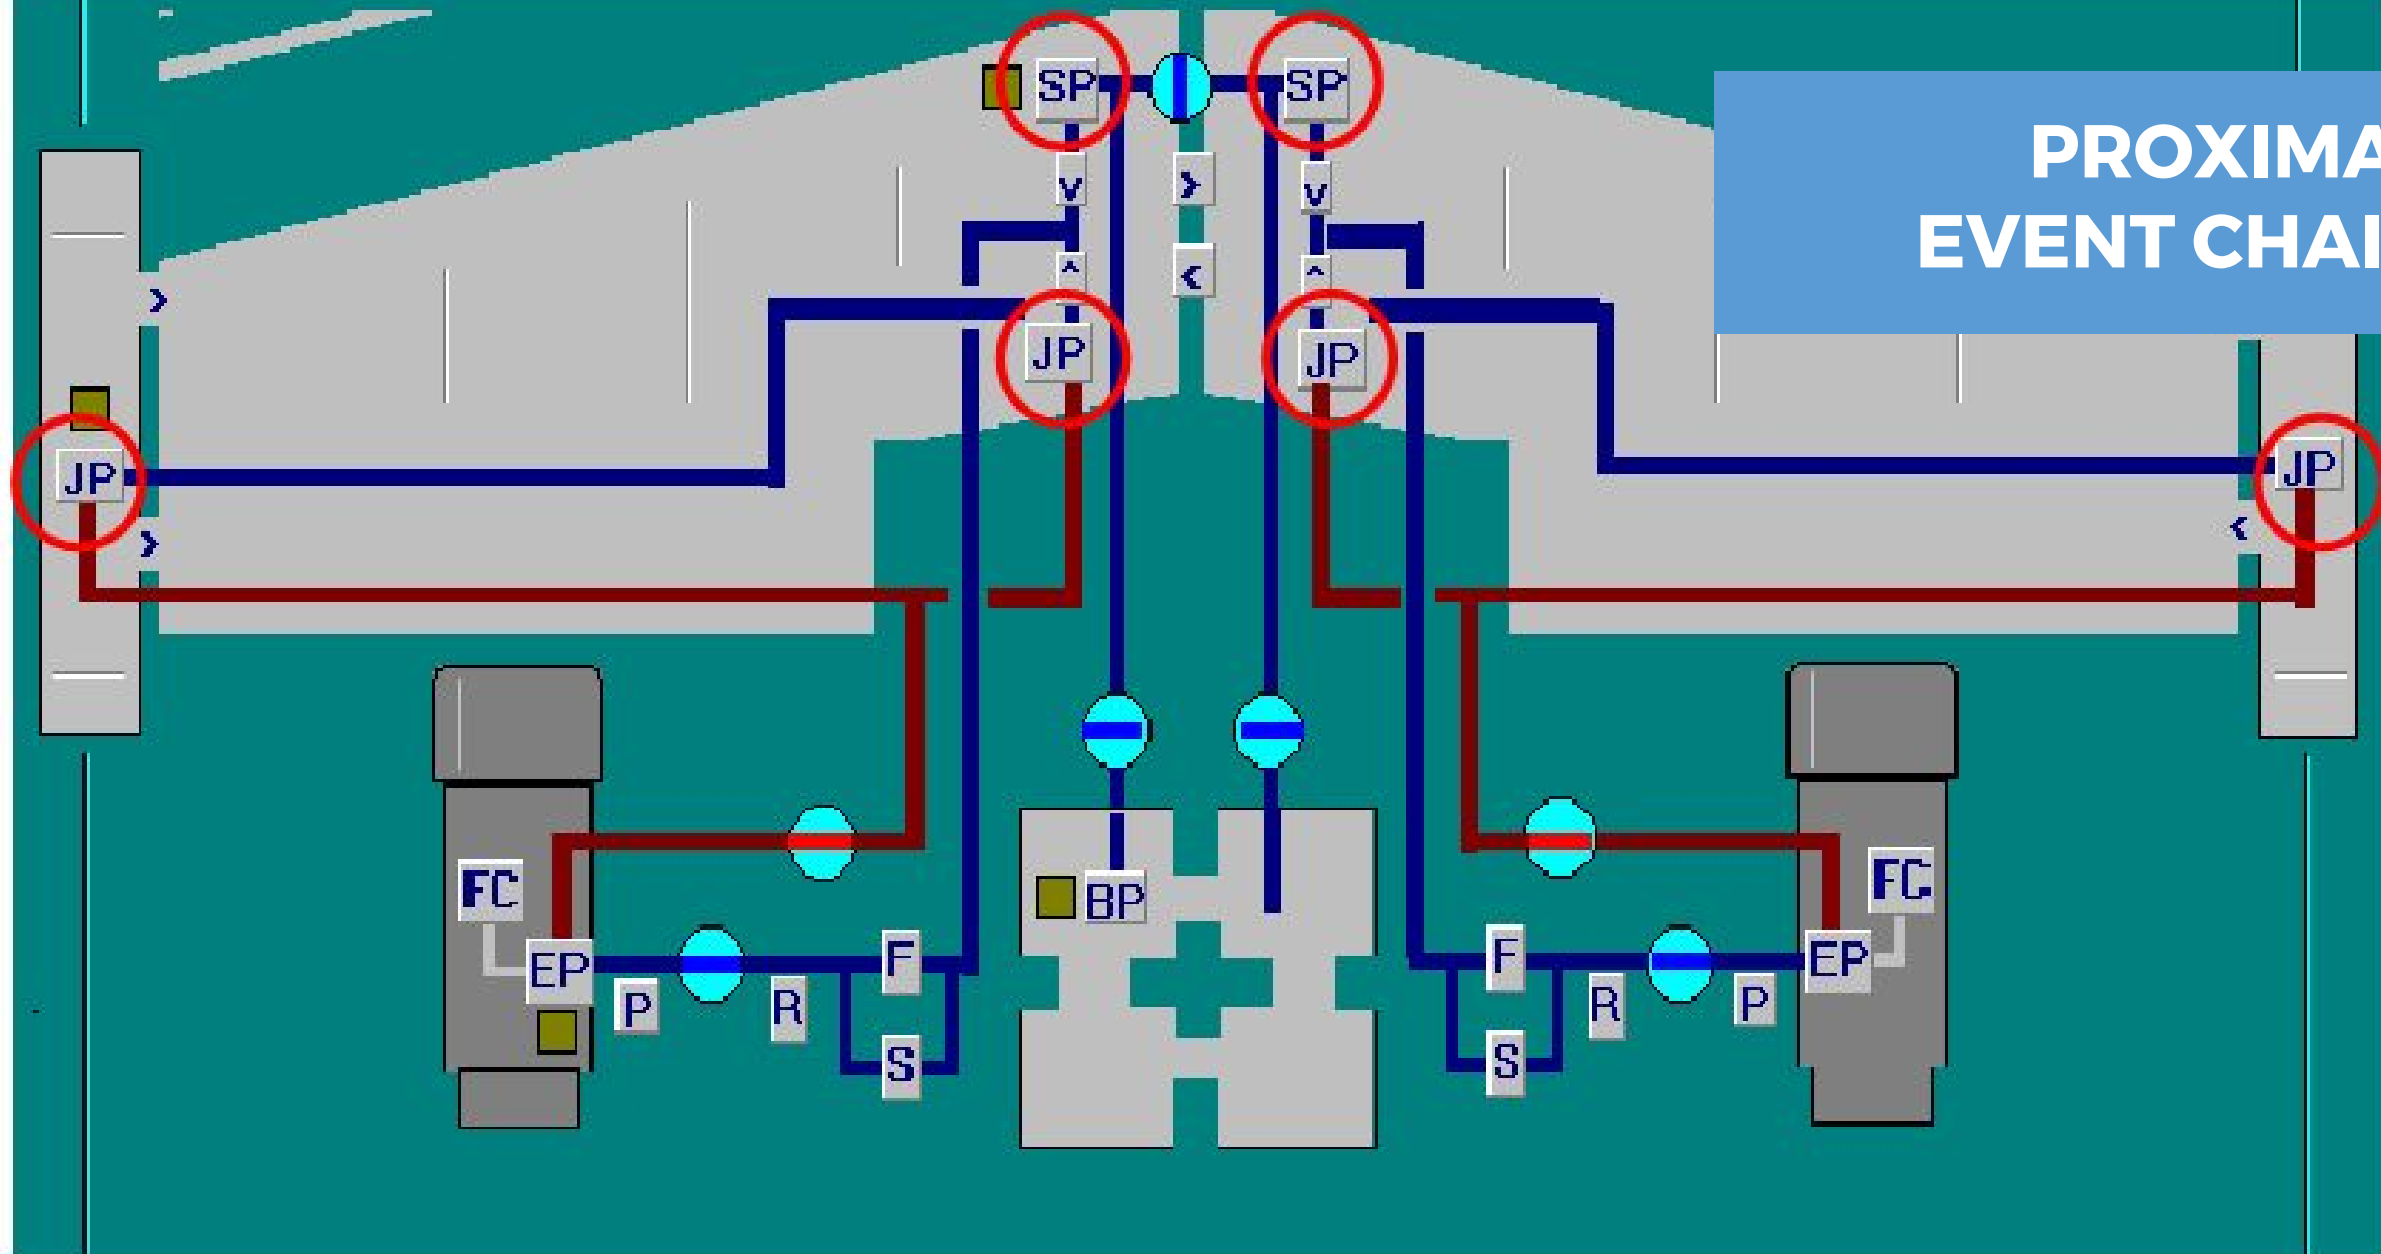
PROXIMAL EVENT CHAIN

- 1. The flight prior to the accident was performed with the Pilot in charge of the piloting without any reported damage or abnormality;**
- 2. During the preparation of the cockpit for the flight, which is performed by the Copilot without the presence of its instructor, a sound similar to the operation of the standby pump and the cross flow valve is emitted for an approximate period of 3 minutes (CVR);**
- 3. At refueling, under Pilot's supervision, 880 lb of fuel is placed through the left wing tip tank supply nozzle and then 880 lb through the right wing tip tank supply nozzle;**
